Lineside materials - vandalism

Ref: NRB 18/20

Location: Gilberdyke, LNE

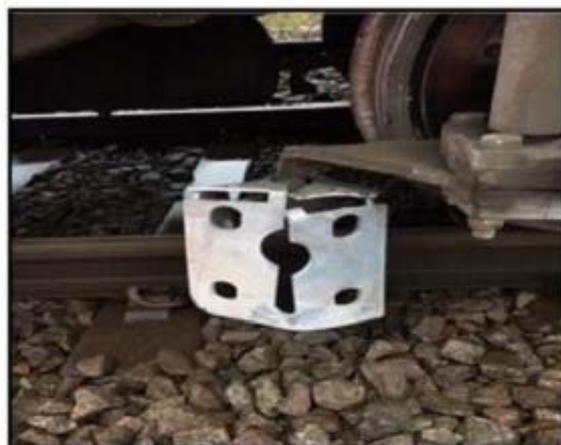
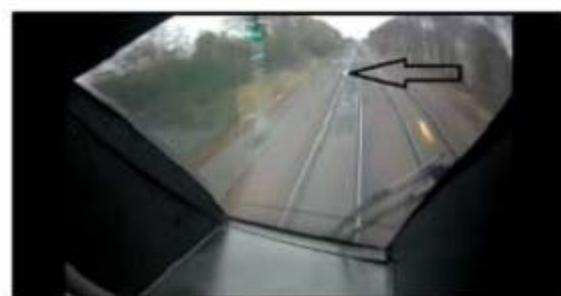
Initial investigation found the train had struck a c20kg metal signal wedge that had been left trackside awaiting recovery after recent signalling project works.

It seems likely that the signal wedge may have been placed on the rail head intentionally. British Transport Police are investigating. This could have derailed the train as similar incidents of vandalism have demonstrated.

Keep your work area tidy at all times and never leave the following and similar items unattended trackside:

- Cable drums.
- Rail lengths of less than 6m.
- Wooden sleepers unless banded in groups of six and secured by a ground anchor a safe distance from the running line.
- Troughing unless stacked and banded in groups weighing not less than 800kg.
- Remove large equipment / trolleys from site or secure to a ground anchor or other fixed object.
- Remove scrap immediately from site wherever possible.
