Safety Bulletin

Kings Cross remodelling runaway MEWP

Ref: NRB21-04

Location: Kings Cross Remodelling, East Coast route

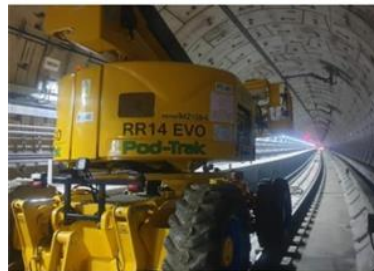
On 16th May 2021 at around 03:30am Pod-Trak were on-tracking their Mobile Elevating Work Platforms (MEWPs) for OLE works. While on-tracking the third MEWP, it ran away approximately 600m into Canal Tunnel. The MEWP ran through the worksite marker but remained within the possession limits. The team working with the MEWP were unharmed.

RAIB inspected the MEWP to establish if there was a mechanical failure. The initial findings were that there appeared to be insufficient brake force to hold the MEWP on the Road Rail Access Point which had a 1.55 gradient.

Later, under test conditions, the MEWP started to move at a gradient of 1.50. A further test was conducted with the hydraulic brake bypass valve closed during the test. When retested, the MEWP braking system worked correctly. The cause of the runaway appears to be that the override valve for the rail wheel parking brake system had been left in bypass during maintenance sometime before the shift.

- What checks are undertaken after maintenance to ensure plant is correctly set up to be used on site?
- What assurance is done by plant providers to confirm that maintenance checks are completed correctly and it is ready for use?
- What simple checks can be undertaken at site to assure users that kit has been safely maintained?
- How should we consider runaway risk during planning?
