Rail slide off moving vehicle

Ref: NRA22-01

Location: Hitchin Delivery Unit, Eastern region

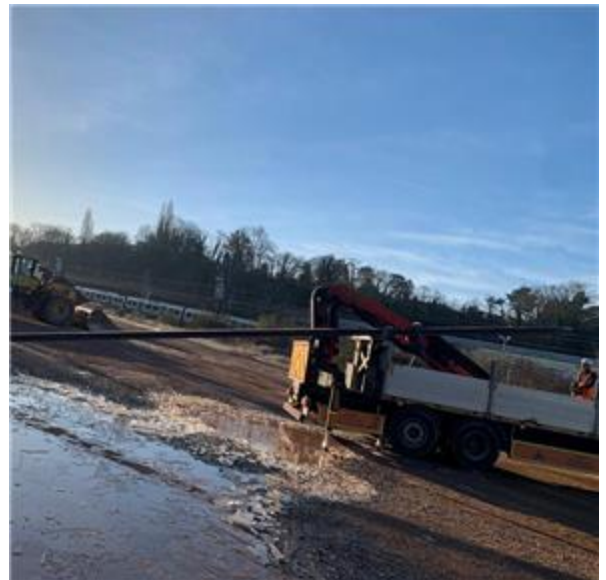
As the HGV manoeuvred to leave the yard the driver heard a noise and stopped. The rails had slipped off the back of the HGV and were touching the ground.

The staff had loaded the HGV many times in the same configuration. It may be that the icy conditions (-4 degrees) helped the rails to slide. But most importantly, the 54-foot rails projected significantly beyond both front and rear load frames, creating flex as the HGV manoeuvred. This type of HGV allows 45-foot rail to sit on the load points without excessive overhang and flex. An investigation is underway.

- No rail longer than 45-foot must be moved using Network Rail's road fleet.
- Rail over 45-foot long must only be moved by road by DHL.
- Loading must comply with our procedures and loads must be checked as being secure.
- All drivers must undertake a load movement safety check before setting off.
