## De-vegetation near miss

Ref: NRB22-01

Location: Uphill Junction, North Somerset, W&W Region

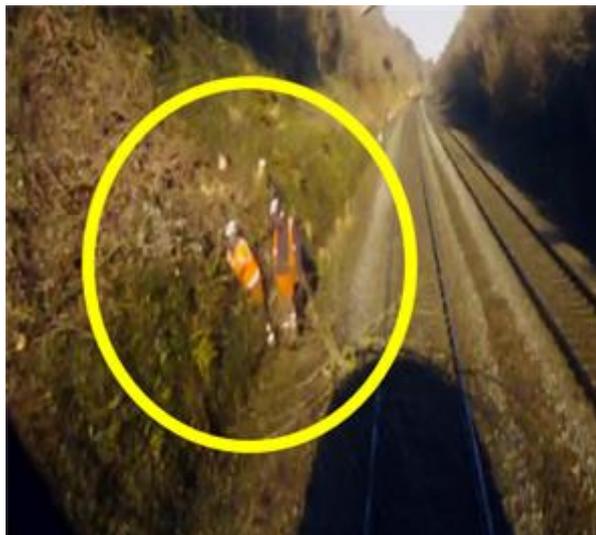
On Friday 14 January at 13:10, a de-vegetation team, with approval from the COSS, made the final cut to fell a small Ash tree (around 4m tall and 150mm diameter) at the top of a cutting slope, just over 3m from the running line.

The tree fell where expected but bounced, falling into the cess with some branches encroaching onto the open line. The team had not used a guide rope as specified in the planned method.

A vegetation operative grabbed the butt end of the tree to try and drag it up the cutting slope, whilst doing so he dragged it onto the open line. The chainsaw operative got down from the bank to help remove the tree from the open line. The COSS alerted the two operatives of an approaching train.
