Safety Advice

Operational Restrictions on use of FSKII Circuit Breakers

Issued to: **E&P Community, Sentinel Sponsors and registered contractors**
Ref: NRA25-10

Date of issue: 02/09/2025

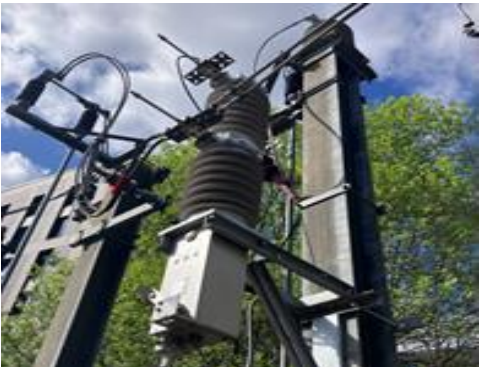
Subsequent investigations have found that a Circuit Breaker, which is an ABB supplied FSKII Circuit Breaker (top photo), had failed in the closed position;

- **Failure Cause:** The operating rod became detached from its base within the high- voltage (HV) pole. This detachment disrupted the mechanical transmission chain between the actuator and the vacuum interrupter, preventing proper operation.
- **Vacuum Interrupter Condition:** The vacuum interrupter was inspected and found to be free of abnormalities. It remains fully functional.
- **Supplier Investigation:** A detailed review of the operating rod’s supplier did not reveal an underlying design flaw.
