Collision between two freight trains in a work site near Ivybridge, Devon, 27 February 2016

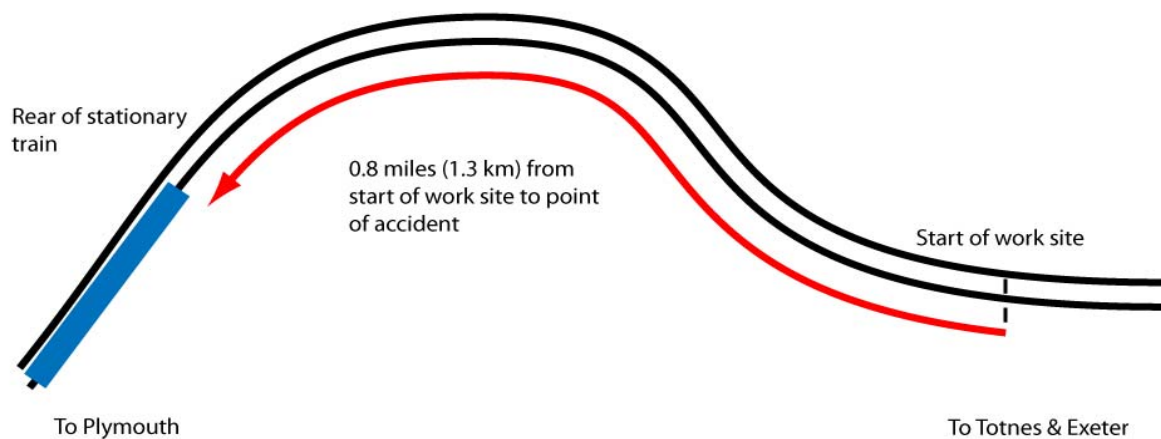
Simplified diagram showing location of the accident

The ES briefed the driver and authorised him to enter the work site and draw up behind a stationary train ahead. The ES did not tell the driver what speed he was authorised to make the movement at, nor did he provide the location of the train ahead nor give a mileage to go to. The driver did not query the missing information or ask the ES to provide it. Evidence suggests that the driver and ES did not reach a clear understanding about the movement to be made.

If an ES (or SWL) does not brief the driver about a maximum speed to travel at in the work site, the Rule Book requires a driver to travel at a speed of no greater than 5 mph (8 km/h) (reference GE/RT8000 module T3, section 9.6). The driver of the freight train travelled faster than this speed. The Rule Book also requires a driver to proceed 'at caution' for any movement in a work site (reference GE/RT8000 module T3, section 9.6). The Rule Book defines 'at caution' as proceeding 'at a speed which takes account of conditions (such as the distance you can see to be clear), that will allow you to stop the train short of any train, vehicle or other obstruction, or the end of your movement authority' (reference GE/RT8000 module TW1, section 25). The driver did not proceed at caution into the curve on the approach to the old Ivybridge station.
