Rail Accident Investigation Branch

Rail Accident Report

Collision at London Waterloo 15 August 2017

Report 19/2018
November 2018

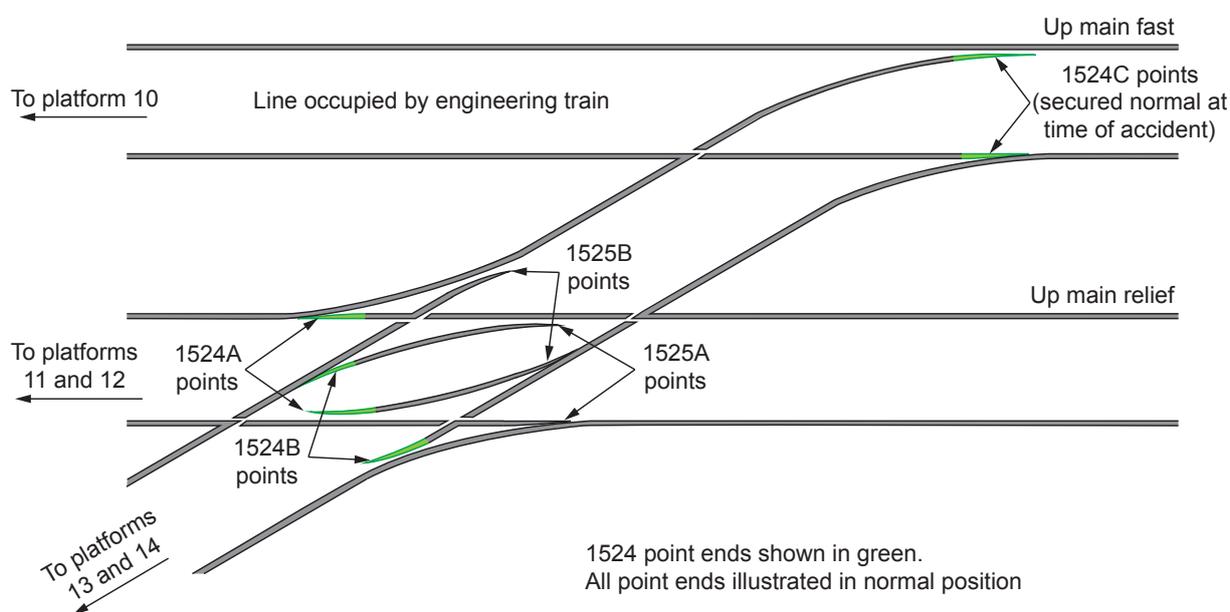
Figure 5: Schematic layout of 1524 points, the accident location

- 22 The three pairs of ends of 1524 points were intended to swing together so that all were in the normal position, or all were in the reverse position. When correctly in the normal or reverse position, the point ends should have been mechanically locked and confirmed to be (ie detected) in this position before a train was permitted to pass over them.

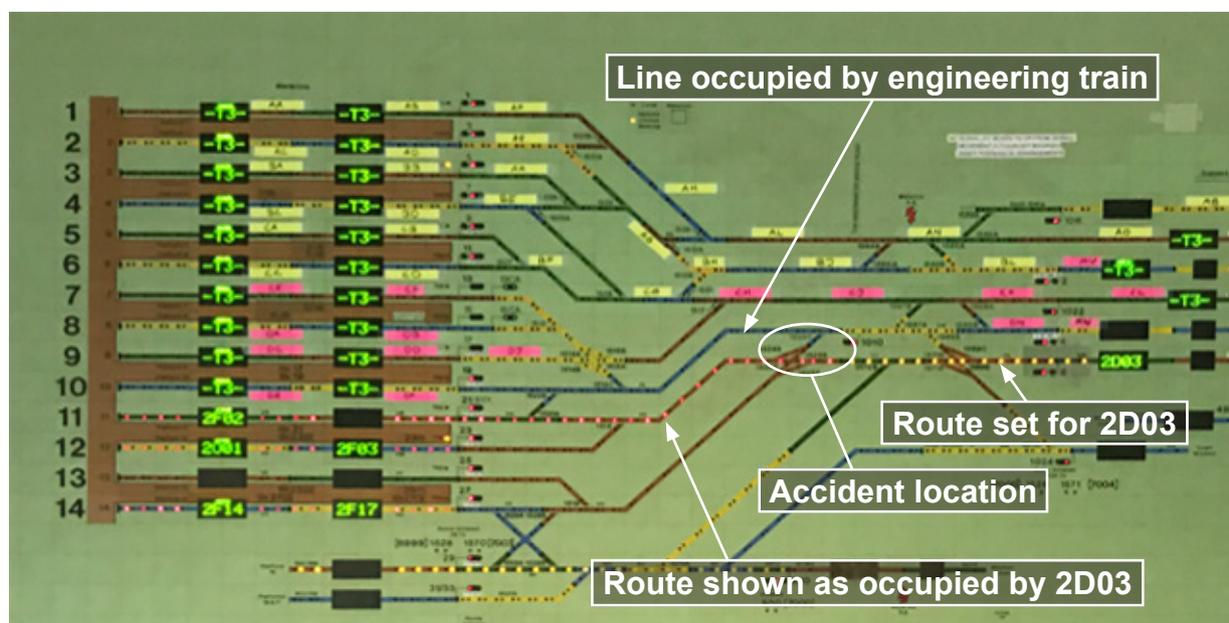
- 29 At 05:40 hrs the signaller set a route for train 2D03 to leave platform 11. The panel display at Wimbledon indicated that it was safe for the train to do this (figure 6). The train driver received a green signal with 'UR' displayed on the adjacent theatre indicator (figure 7). This indicated that it was safe for his train to leave the platform and proceed along the up main relief line. The train departed at 05:41 hrs.

Figure 6: Signaller's panel at Wimbledon showing the route out of platform 11 set for and occupied by train 2D03. (Indicators are not illuminated for the engineering train as inputs were not provided to these indicators during parts of the construction work.)

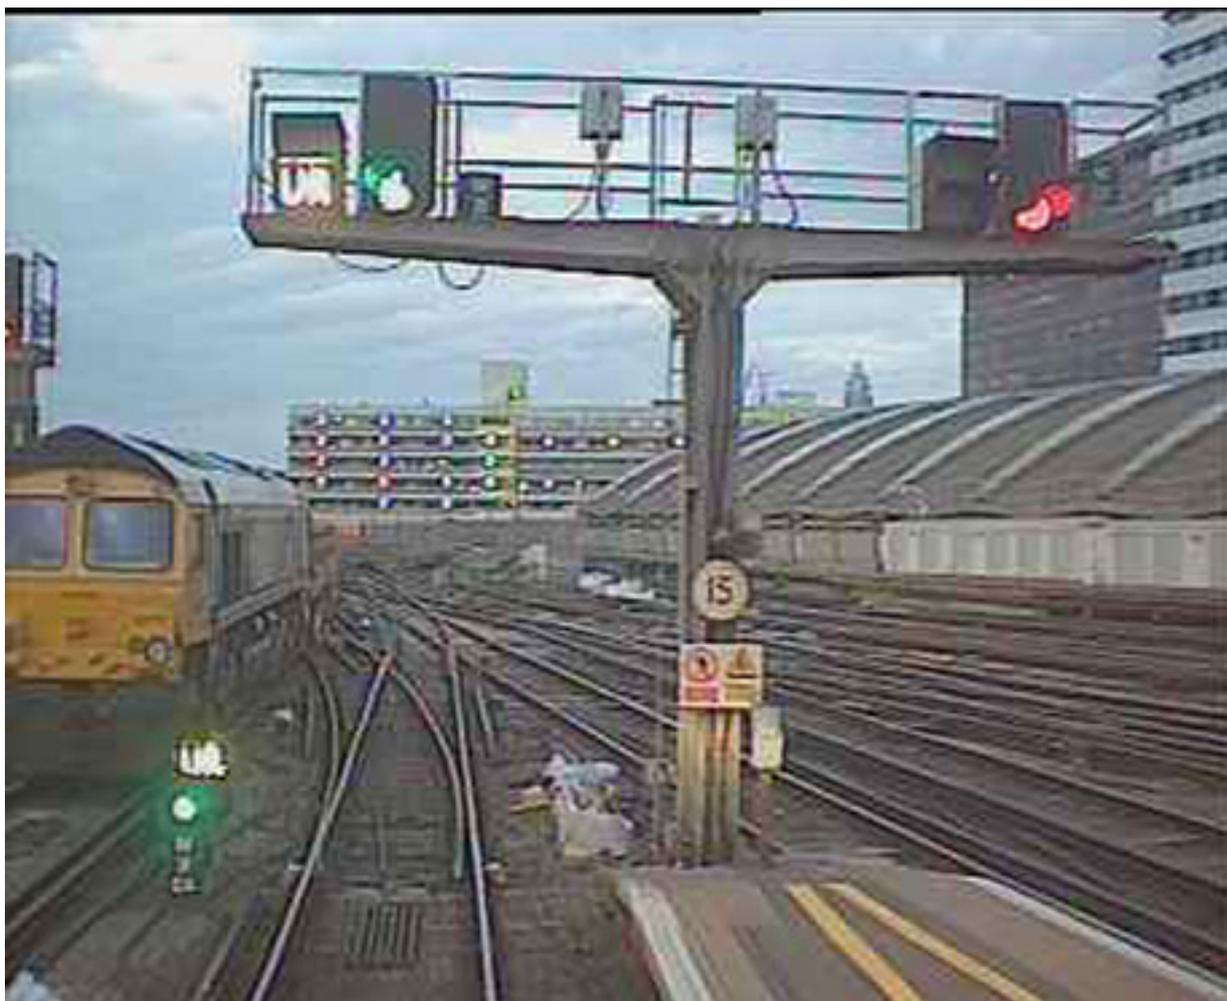
Figure 7: Forward facing CCTV from train 2D03 showing the green signal and 'UR' (up main relief) route indication displayed at high and low levels as it departed from platform 11 (courtesy South Western Railway)

- 84 Images from the passenger train's forward facing CCTV show a green signal with a 'UR' indication displayed adjacent to this (figure 7). This gave the driver authority to proceed out of platform 11 and along the up main relief line, the line running alongside the engineering train. The correct indications for this authority were shown on the signallers' display at Wimbledon area signalling centre (figure 6).
- 85 Less than a minute after the signal turned green, the train was approaching 1524 points and images from the train's CCTV showed the points in an intermediate position between the reverse position and the intended normal position (figure 8).

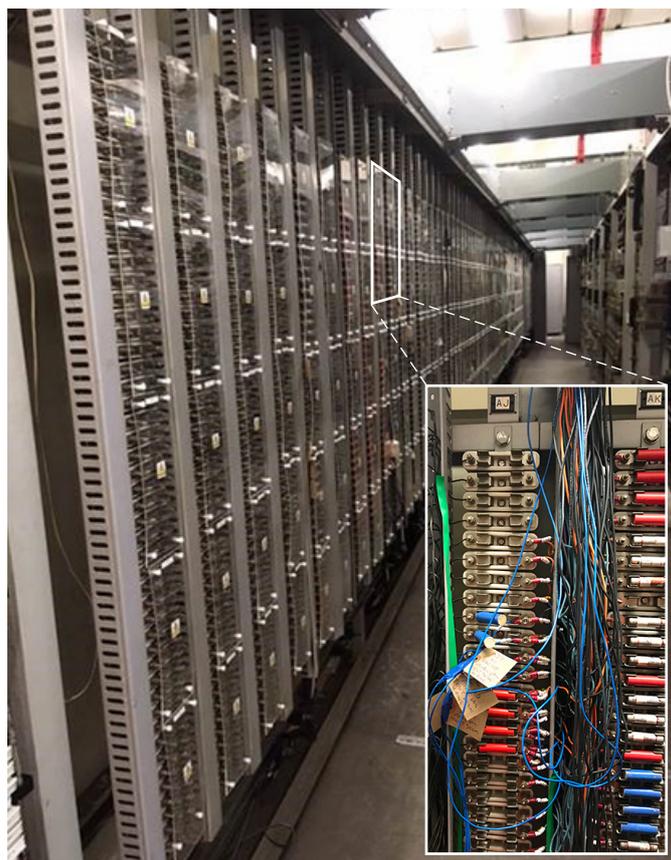
- 57 The detectors on 1524 points are connected by electrical cables to a lineside cabinet (location case W14), and then into the Waterloo relay room (figure 10). Although 1524 points were not physically affected by the upgrade work, the arrangement of the point detection wiring between 1524 points and the relay room was modified when location case W14 was replaced in June 2017 (paragraph 59).

Figure 10: Waterloo relay room with inset including connections from 1524 points and associated fuse holders as detailed in figure 19

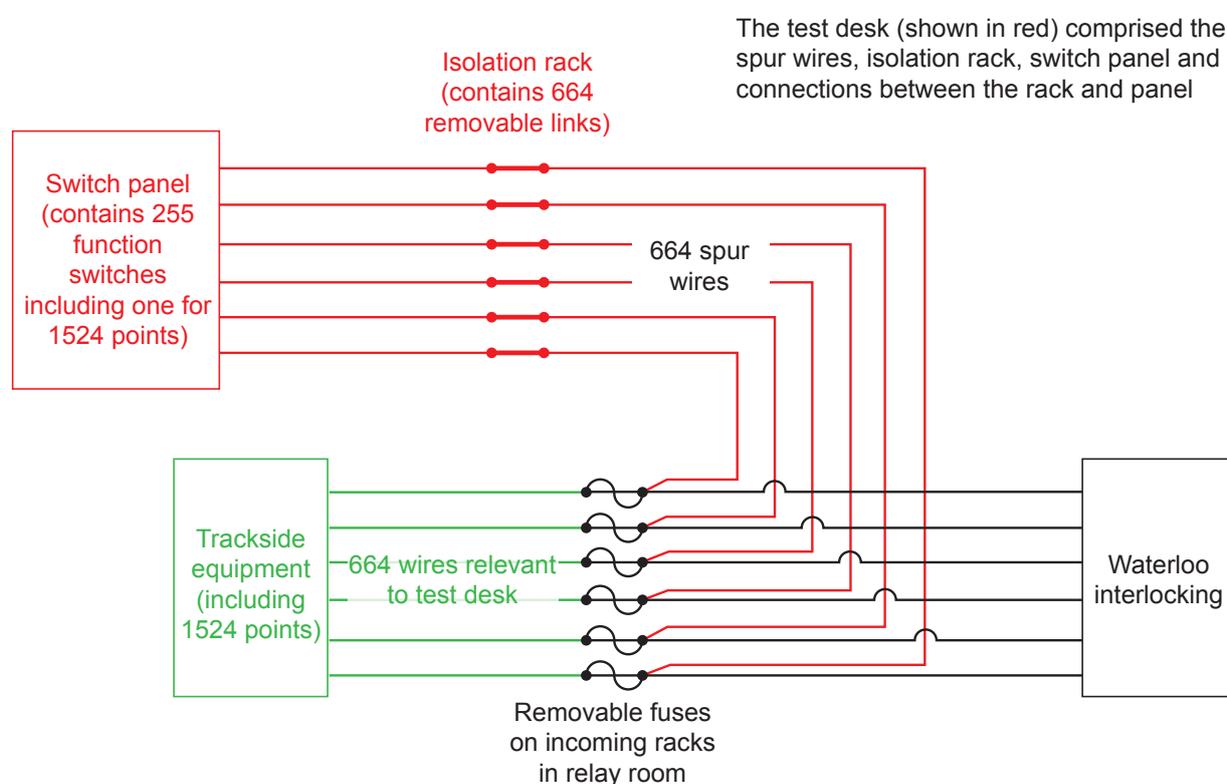
Figure 11: Block diagram of the test desk and connections

- 66 Design and checking of the test desk was completed by OSL in June 2016 (paragraphs 105 to 110). The test desk comprised a switch panel (the controls used to simulate operation of railway infrastructure) connected to an isolation rack which was attached to the interlocking by spur wires (figures 11 and 12).

- 121 When approving the test desk detailed design documents, the CRE approved 65 sheets including 42 wiring sheets showing a total of 664 connections between the spur wires and the interlocking (figure 11). These connections were shown in the same way as permanent connections shown by MML on its own interlocking detailed design documents. There was nothing to imply that the spur wire connections were short term. The 42 sheets showing the spur wire connections also showed the isolation links. These links were attached to one end of each spur wire and would not have been necessary if the opposite end of the spur wires were detached when the interlocking was in operational use.

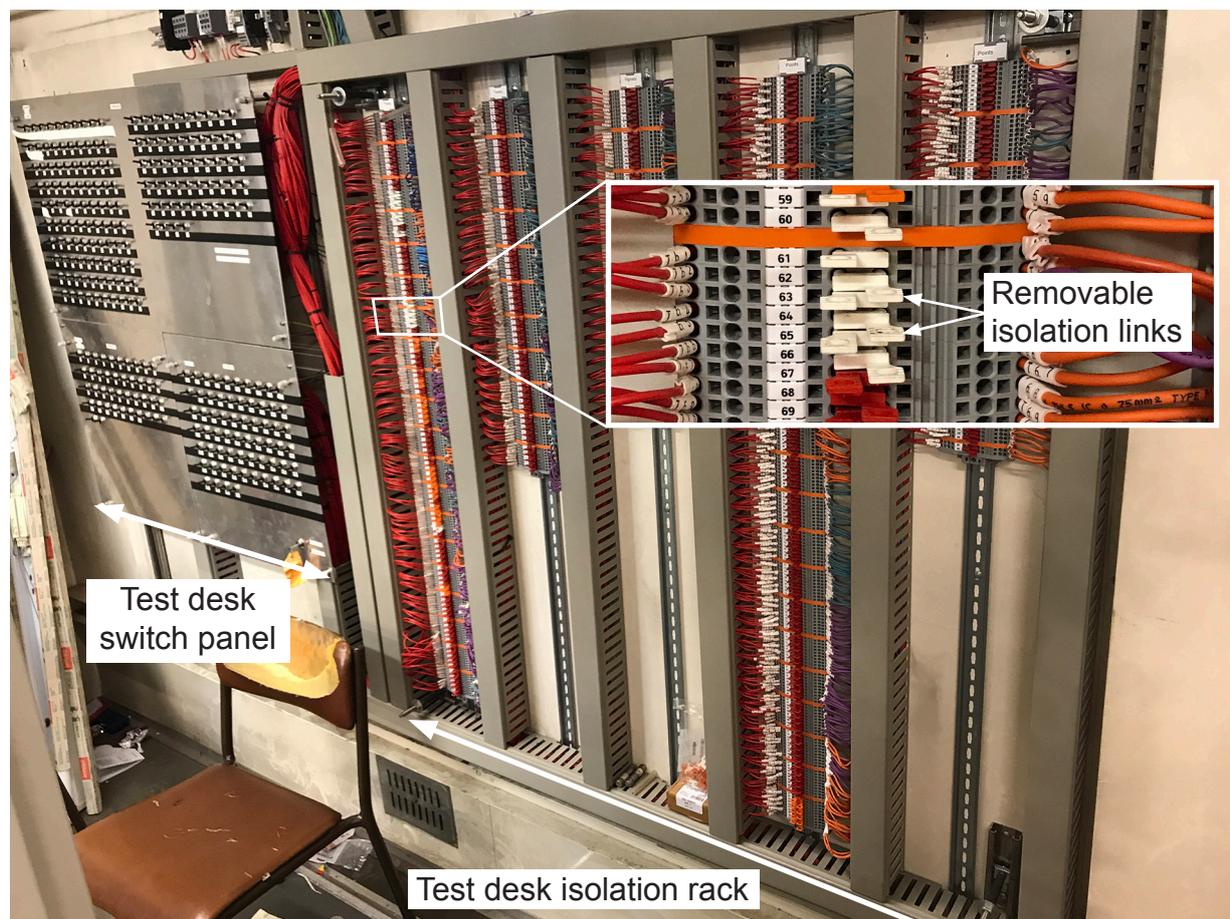
- 67 The spur wires were connected to the interlocking side of fuse holders on circuits linking the interlocking to trackside equipment. These wires remained connected to the interlocking fuse terminals at all times. Testers removed fuses and inserted links in the isolation rack to allow the interlocking to respond to the simulated inputs from the test desk switch panel, and not to trackside equipment. Once testing was complete, removing the links from the isolating rack disconnected the switch panel from the interlocking and re-inserting the fuses caused the interlocking to respond to inputs from trackside equipment.

Figure 12: Test desk switch panel and isolation rack in Waterloo relay room. White links are conductive, red and orange links are dummy (isolating) links which are fitted to prevent unintentional fitting of conductive links.

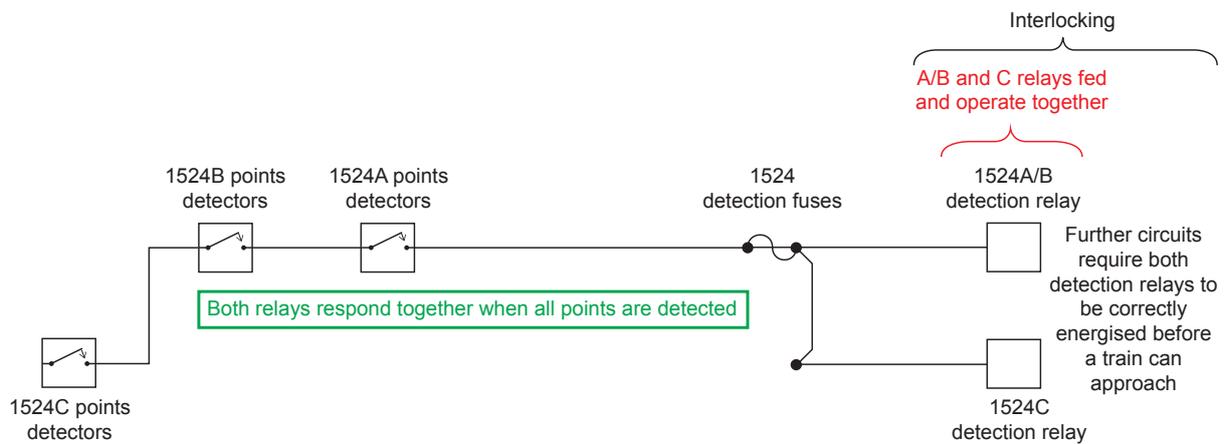
Figure 13: 1524 points detection before work began

- 91 Before the works began, the point detectors for each of the three ends were wired in series, meaning that all three ends had to be in the same position before any current was returned to the normal or reverse detection relays (figure 13). This current was then used to energise the appropriate relays designated 1524A/B and 1524C. Although designated A/B and C, these relays were fed by detection circuits passing through all three point ends. Further circuitry in the interlocking required the detection relays to be energised before signals could display a proceed aspect to permit trains to approach 1524 points.

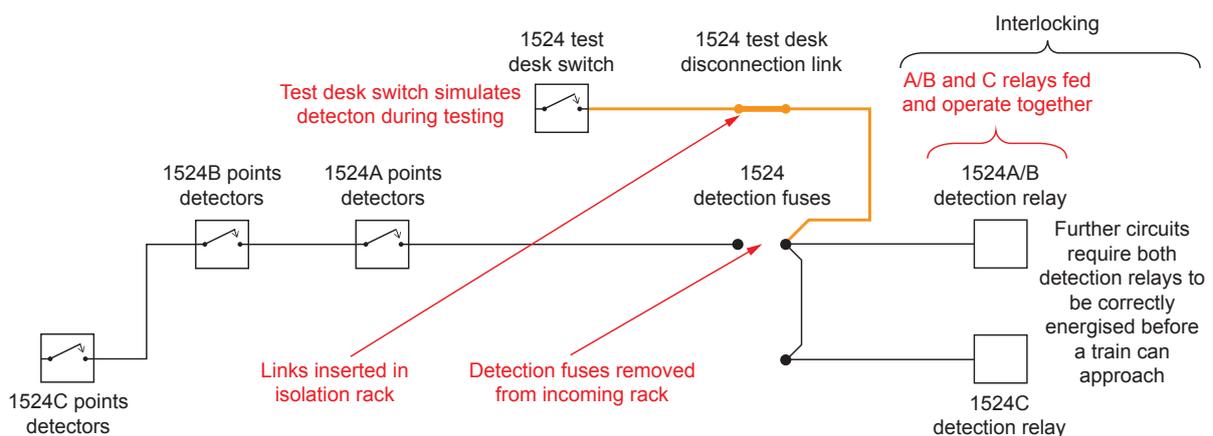
- 92 When the test desk was installed in August 2016, spur wires were attached to the detection fuse terminals which fed both 1524A/B and 1524C detection relays. When used to simulate the operation of 1524 points, the test desk correctly energised these relays (figure 14).

Figure 14: 1524 points in test mode, before location case W14 was replaced

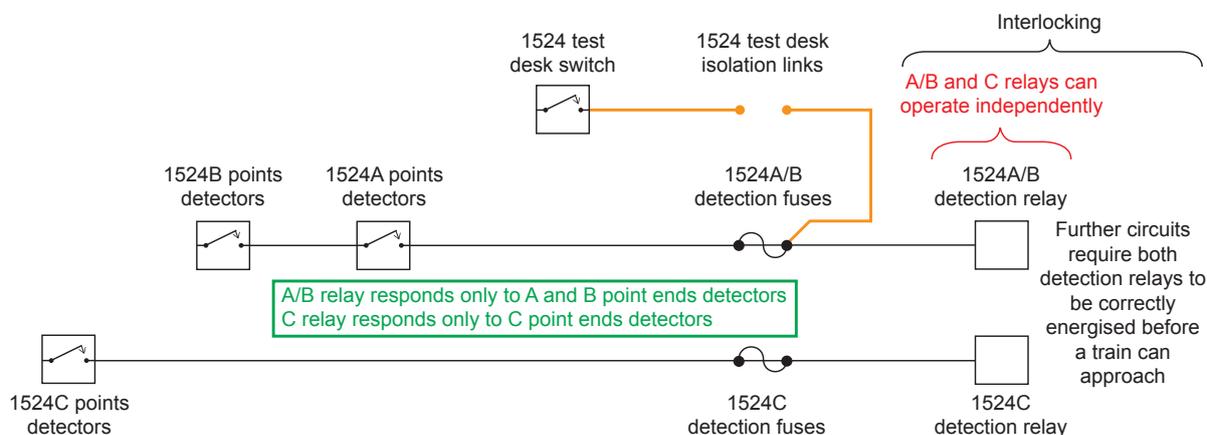
- 93 The detection wiring from 1524 points passed through location case W14. When this was replaced in June 2017 (paragraph 71), the wiring was altered so that A and B detection circuits energised only 1524A/B detection relays and the C end detection circuits energised only 1524C detection relays (figure 15). As before, further circuitry required both detection relays to be energised before trains were permitted to approach 1524 points.

Figure 15: 1524 points detection after location case W14 was replaced (no uncontrolled wiring)

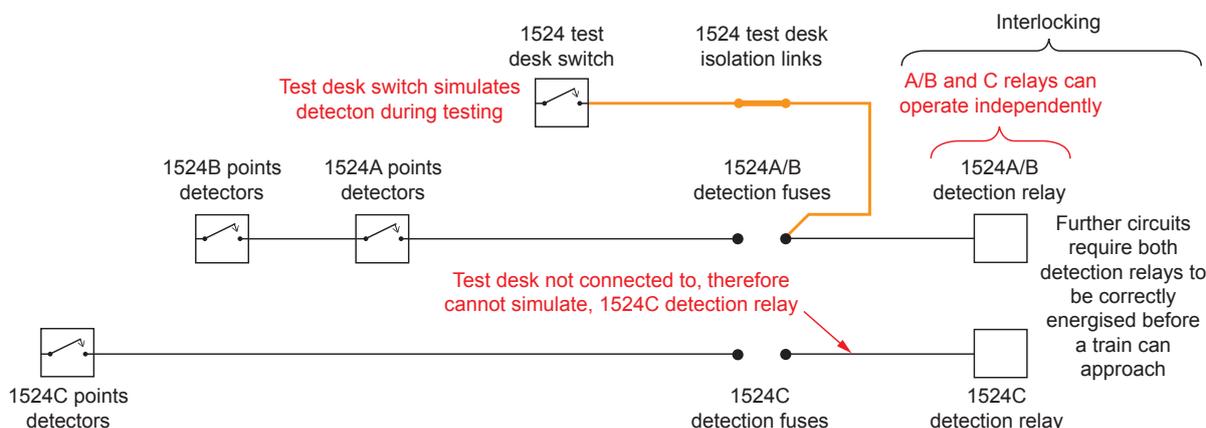
- 94 These modifications to the wiring of 1524 points detection (paragraph 71) did not affect the safety functions provided by the interlocking but did mean that the test desk no longer simulated the detection of 1524 points correctly because 1524C point ends were no longer connected to it (figure 16). This would not be apparent until testers required the test desk to simulate the position of the points.

Figure 16: 1524 points in test mode after replacement of location case W14 (no uncontrolled wiring)
