Learning from history:

Lessons from past accidents 1981-2017

Produced by RAIL magazine

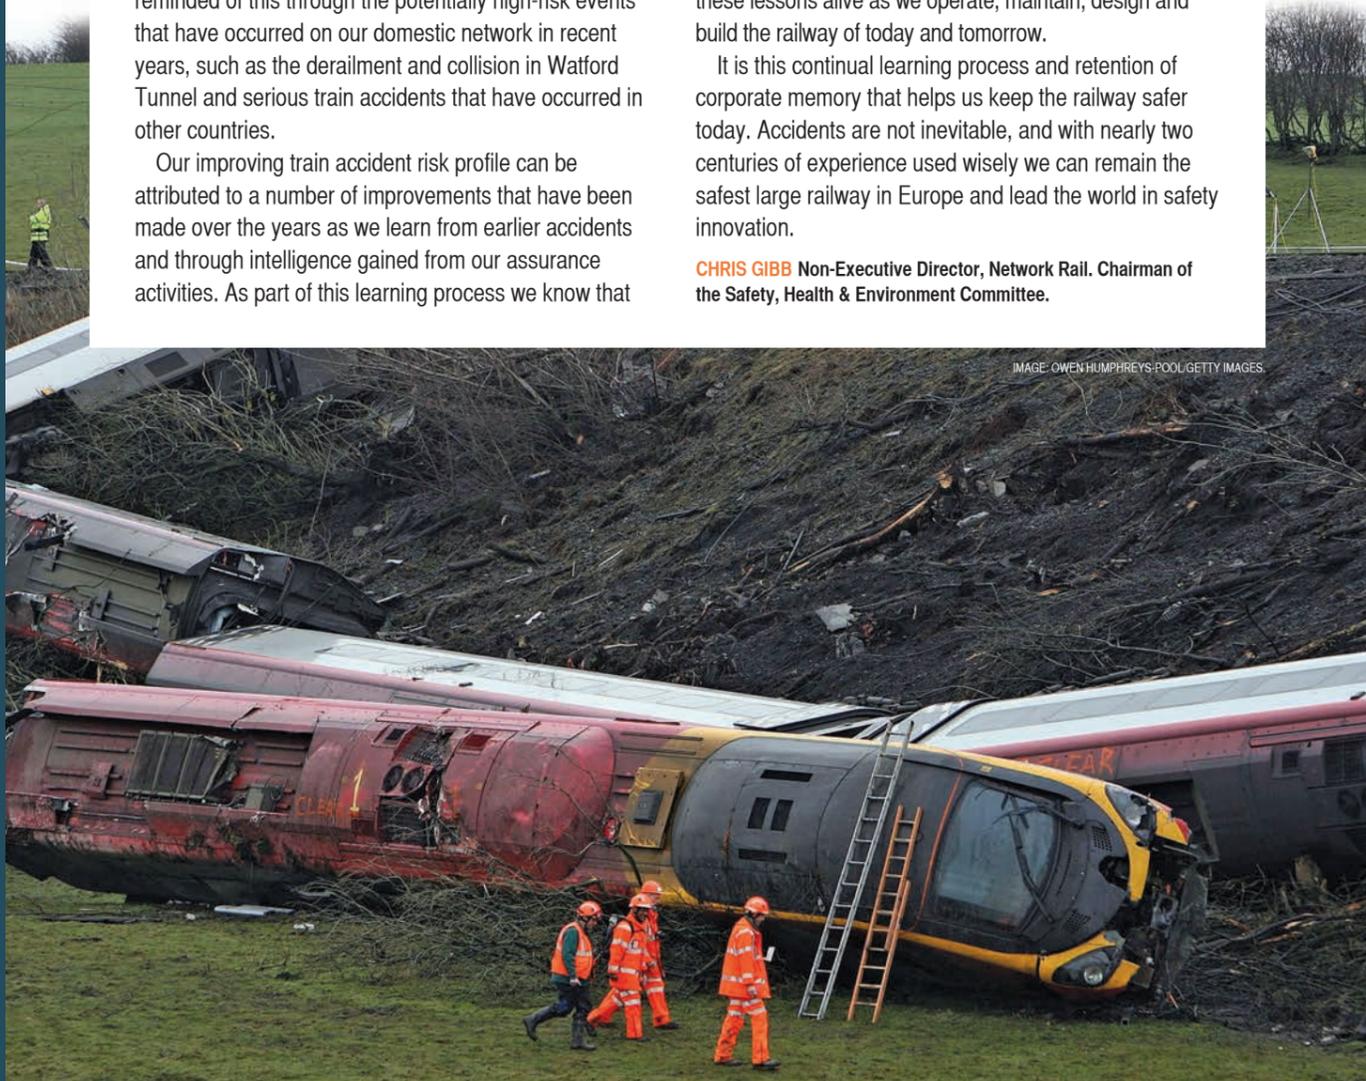
On February 23 2007 a passenger died when a Virgin Trains Pendolino derailed at 90mph near Grayrigg (Cumbria). The accident was blamed on poorly maintained pointwork. The railway has learned many important lessons from the incident. RAIB.

Both the rail industry and Rail Accident Investigation Branch (RAIB) investigations confirmed that the train derailed on a crossover, the immediate cause being the condition of the pointwork. The train itself, however, was widely praised: its crashworthiness serving to minimise the harm to all those on-board.

Poor maintenance was also implicated five years later, when a Class 390 Pendolino derailed on a groundframe-operated facing crossover at Grayrigg. RAIB's investigation confirmed the immediate cause to have been the condition of the stretcher bars. Between the three, one was not in position, another had nuts and bolts missing and two were fractured.

More fundamentally, neither fixed nor adjustable stretcher bars had ever been designed with an engineering understanding of the forces to which they would be subject. Now, a new design of tubular stretcher bar - which has designed out a number of failure modes - has been introduced.
