# ***Infrastructure Projects Signalling Shared Learning***

Issue 18/01: July 2017 – February 2018

This Shared Learning document details key issues and incidents that have occurred on Signalling Projects between July 2017 and February 2018; and provides the key learning points associated with them.

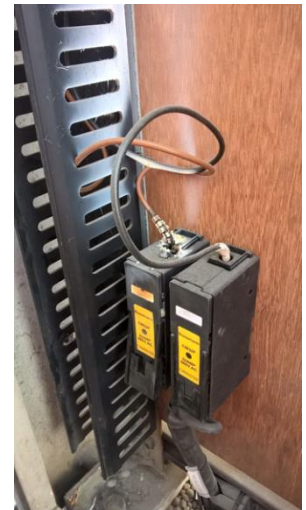
## Loose Cable Termination

Heat damage was caused to a location case (see photo right) due to a loose cable termination.
