## Scaffold incident at London Liverpool Street Station

Ref: NRL25-03

Date of issue: 23/07/2025

Location: London Liverpool Street Station

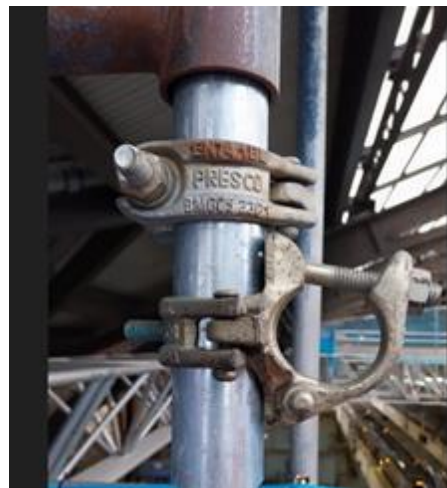
The coupler landed within an exclusion zone that had been established on the station platform, resulting in no injuries or damage.

The investigation concluded that the coupler had not been correctly tightened and vibrated loose when the scaffolder was working on an adjacent fitting.
