Scaffold incident at London Liverpool Street Station

Ref: NRL25-03

Date of issue: 23/07/2025

Location: London Liverpool Street Station

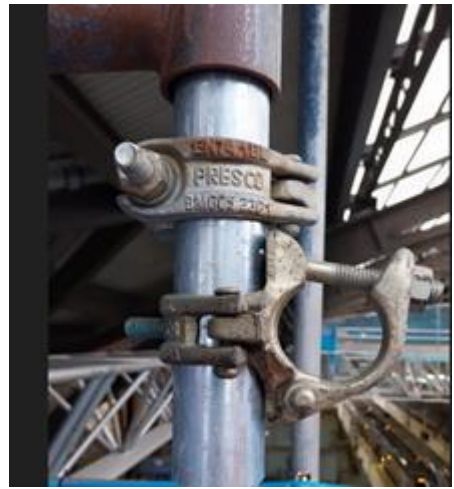
During the installation of a tube and fitting hanger for a suspended scaffold, a supplementary check coupler fell approximately 15 metres onto one of the station platforms.

- The check coupler fell because it was not correctly tightened. The orientation of the check coupler prevented the scaffolder having visibility of the bolt head whilst tightening the fixing. This led to the bolt being insecure, and vibrations from ongoing work caused the coupler to loosen and fall.

The coupler landed within an exclusion zone that had been established on the station platform, resulting in no injuries or damage.

The investigation concluded that the coupler had not been correctly tightened and vibrated loose when the scaffolder was working on an adjacent fitting.
