# *Share with Pain*

# *SwP004/13*

*Bromfield Level Crossing*

*Infrastructure Projects*

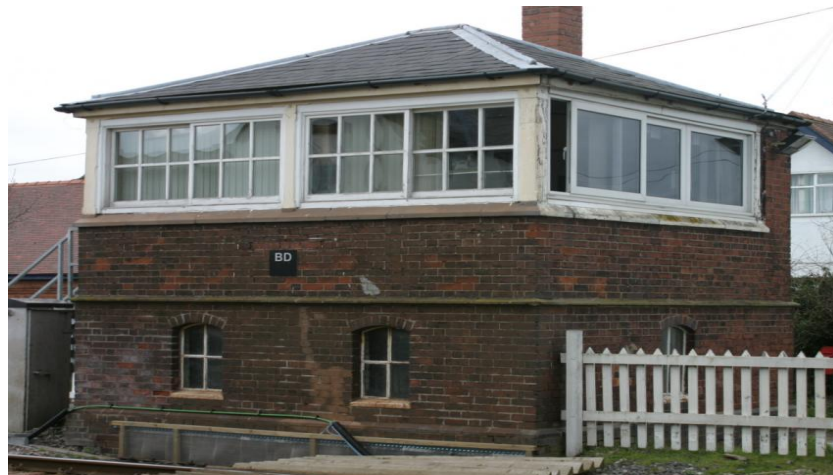
Bromfield LX had 'Moreton-on-Lugg' controls fitted 18/19th May 2013.

The circuitry did not operate as expected on the night of the commissioning and an alteration was made to the circuitry in the electro-mechanical interlocking by the testers, without referring to the design office.
