SHARE WITH PAIN

Electrical Rail Shoes Ripped off by Dropped Rail in 6ft at Radlett

Tuesday 17th June 2014 at 07:58hrs

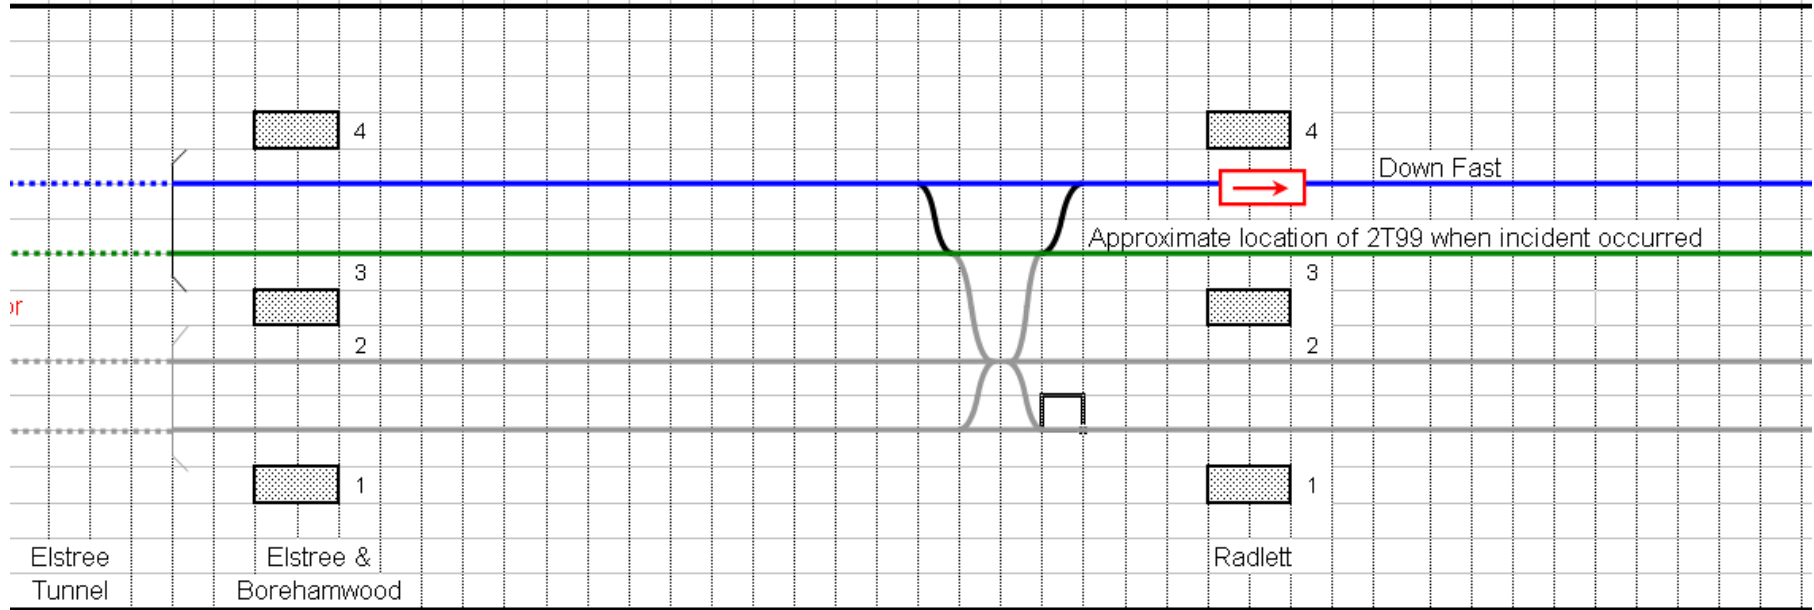
Incident occurred on the Down Fast, the train's 3rd rail conductor shoes and air hose hit CWR rail that had been dropped in the 6ft at Radlett Station.

In addition rail in the 4ft was found to be close to the edge of the running rails in some areas.
