Independent report

# Runaway and derailment of a rail vehicle near Bury, Greater Manchester, 22 March 2016

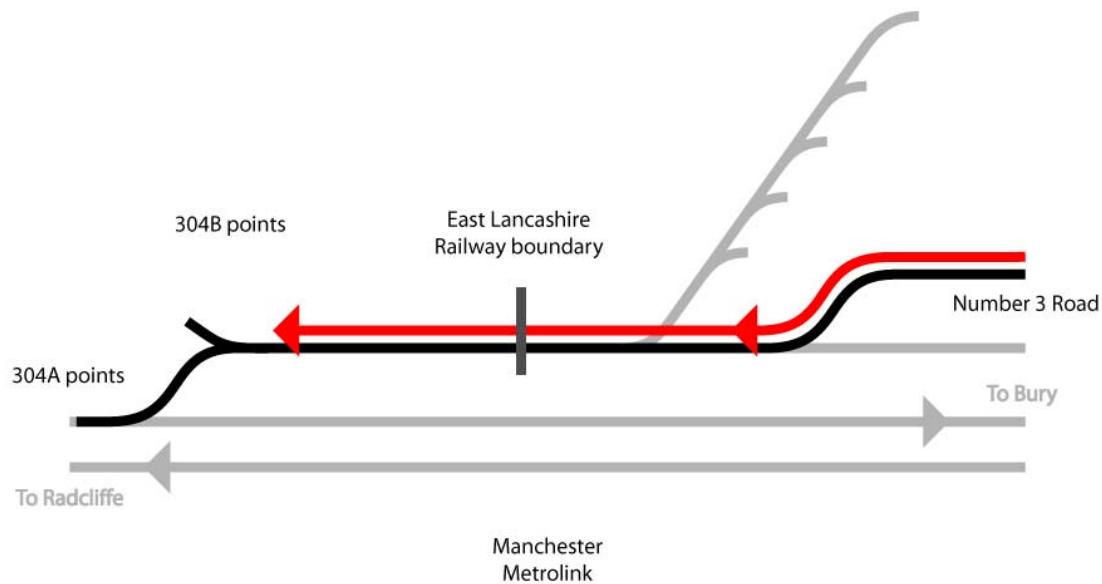
Simplified diagram showing the track layout (not to scale)

During these tests, the MPV was brought to a stand on Number 3 road, towards the southern end of the yard. Because the responsiveness of the brakes remained a concern, the driver decided to check on the air-brake distributors and left the cab at the southern end of the MPV (which was the active cab). After the driver had left, the driver-assessor shut down the southern cab so that he could change ends in preparation for a further test run. Shutting the active cab down vents the automatic air brake pipe and should ensure that the MPV's air-brakes remain fully applied.
