Independent report

# Signal passed at danger near Ketton, Rutland 24 March 2016

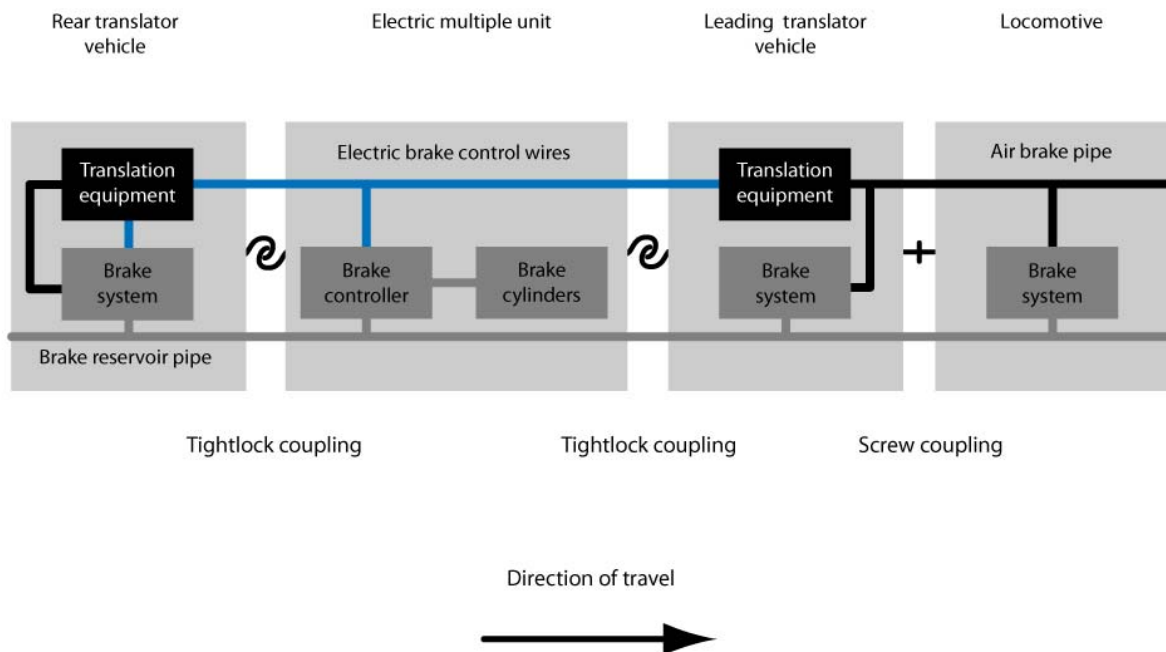
Diagram of train coupling system and braking systems, correctly configured for train movements

In normal operation, the driver controls the pressure in the air brake pipe in the locomotive, which indirectly operates the brakes on the locomotive and on the lead translator vehicle. The lead translator vehicle converts the pressure in the air brake pipe to electrical signals which are sent to the EMU and on to the rear translator vehicle. These signals then control the brake systems on the EMU and on the rear translator vehicle.
