# Water Pollution & Flooding Events

Learning from Events Week

Recent Environmental Incidents – Sharing Lessons Learnt

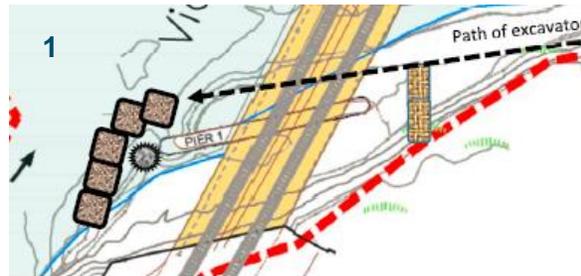
Phased approach with temporary cofferdams in situ to mitigate impacts

Work to be undertaken under low water conditions when there is no flood warning in place. Excavator containing bio hydraulic oils to slowly travel up the river and place the 1 tonne silt curtains. Once the temporary works are in place the remaining causeway material shall be removed.

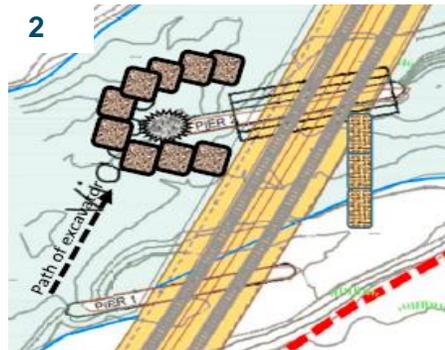
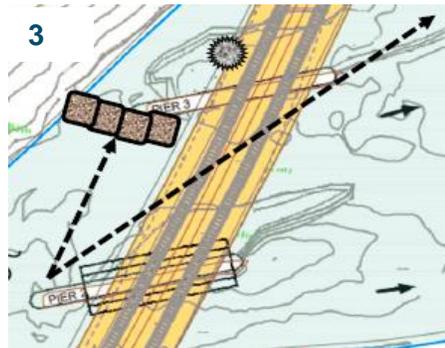
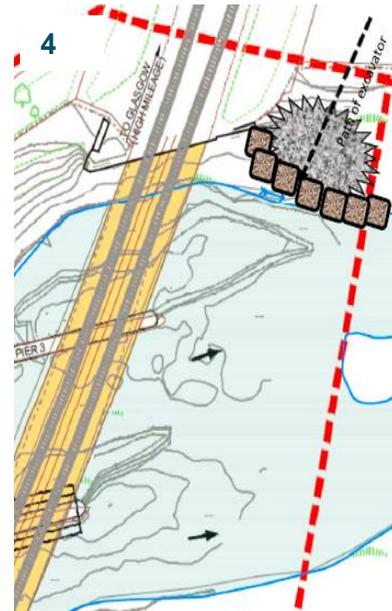
Work to be undertaken under low water conditions when there is no flood warning in place. Silt curtains shall be moved and placed at the toe of the ramp to divert the water flow away from the embankment to remove the access ramp. Once the temporary works shall then be removed. Once works completed the silt curtains at the road bridge 100m downstream shall be removed.

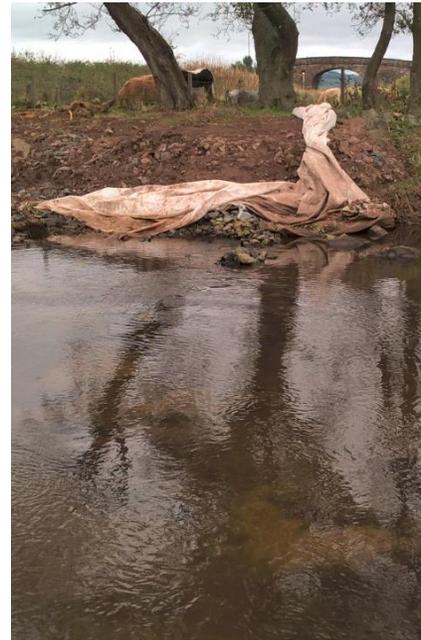
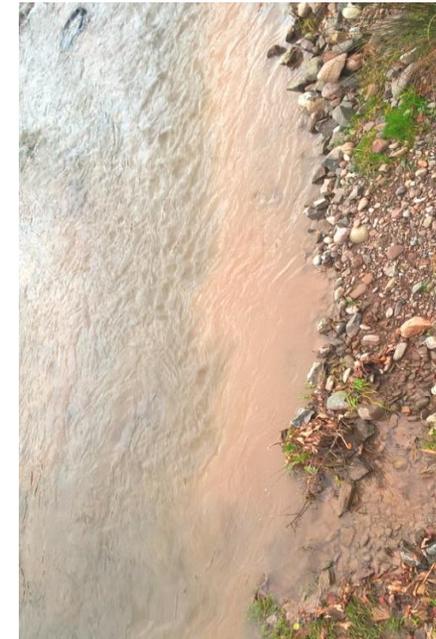
[SEPA Major Enforcement Undertaking](#)

- No Cofferdam or protection upstream
- Excessive amount of silt washed downstream of silt curtains,
- No CAR license on site (Required)
- Limited key documentation available
- Significant amounts of waste and detritus in water and no skips or waste management on site
