Share with Pain

SwP019/16

Manchester East Westcad System

Software crash – August 2015

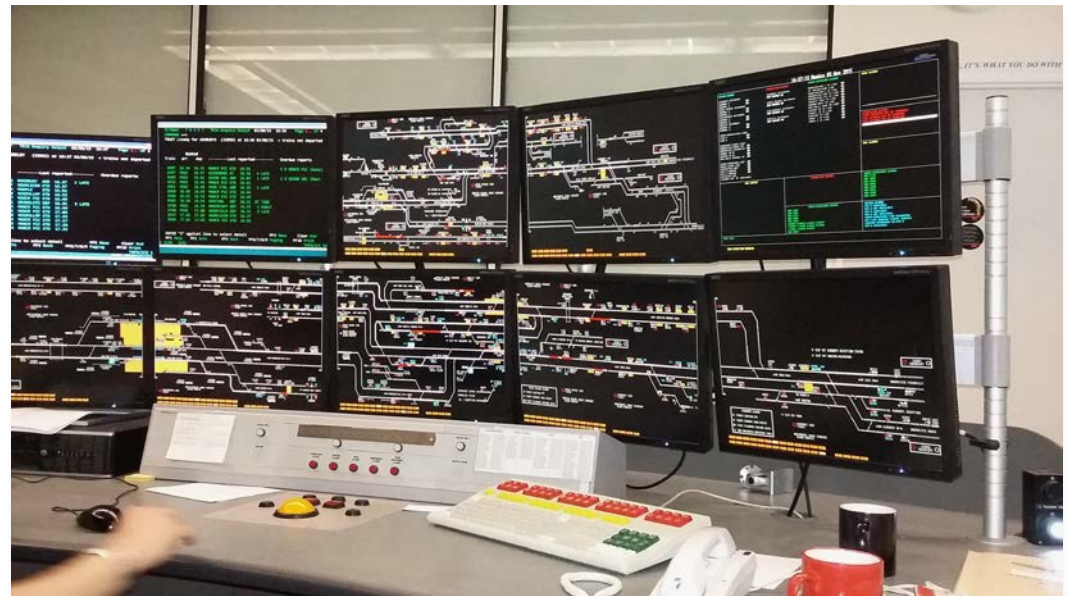
Site Configuration

Manchester East is a SCC installation using “Classic” Westcad but with a Dual-Parallel Workstation arrangement. It controls Ashburys, Guide Bridge, Stalybridge and Romiley RRIs with no ARS

- Two Operators
- Windows NT
- Compact PCI
- Separate TD system
- Four Remote RRI
