## Appendix A – 3350/171

### Infrastructure Group Safety Bulletin

#### MEWP Incident at Milton Keynes

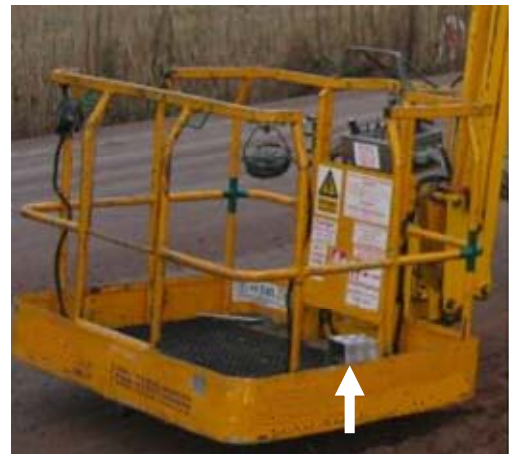
- As part of the pre-work checking of the machine, the positive operation of the 'dead man' control (usually a foot switch pedal) must be checked to ensure that the functional controls of the machine can be stopped in an emergency. If there is any doubt about the positive operation of this control, the vehicle must not be used until the MEWP's maintainer has passed the vehicle as being 'fit to be used' and that this is recorded and dated in the vehicle's log book.
- To avoid the risk of an entrapment situation occurring, the system of working to be followed requires that the basket is not to be raised directly under a structure, but off to one side of the structure, to a height just above the desired work height. The basket can then be lowered and manoeuvred towards/under the structure in full view of the operator by either slewing the basket or traveling the machine in creep drive
