Shared Learning from a Formal Investigation

Document ref: NRL 14/02

Title: Stafford Up Arrival Siding ; Staff electric shock from OLE ; 05/11/13

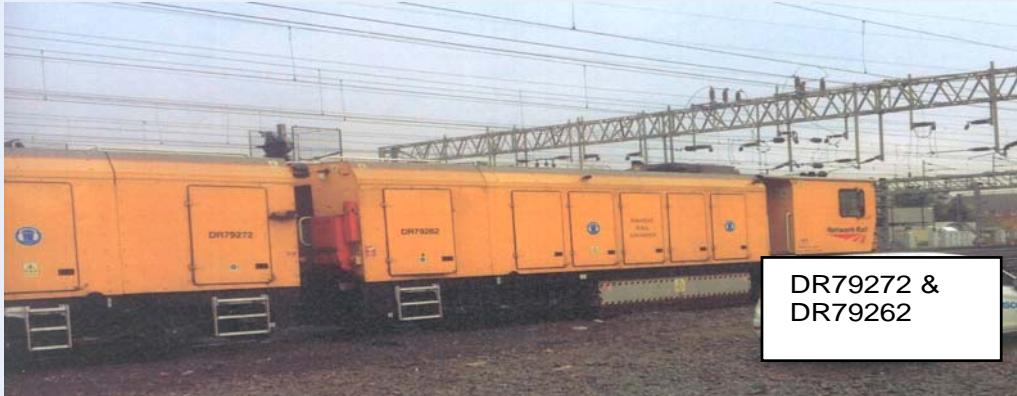
- On 05 November 2013, at Stafford Up Arrival Line No.2 a driver/operator/maintainer (DOM) employed by Harsco Rail sustained an electric shock following accessing the roof of RGH-20C Switch and Crossing rail grinder No.DR79262.

- Equipment on top of the machine consists of exhaust rain caps, louvers above various fans, air-horns and antennas for communication. None of these were scheduled to be checked on a daily or weekly basis and no defects had been recorded by the machine operators.
