Safety Advice

Burnt hydraulic hoses on Permaquip HSM70 Hydro Stressor

Ref: NRA 16/05

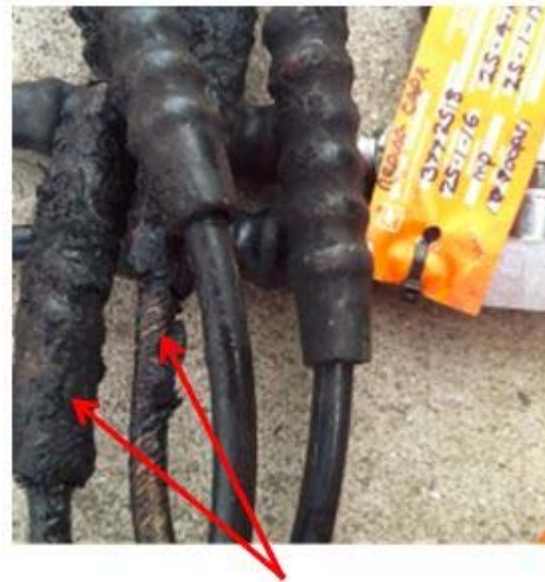
Damaged Hoses

During an inspection of a Permaquip HSM70 Hydro Stressor a fitter identified burn damage to the hydraulic pressure hoses at the coupling end of the equipment; the equipment was being held in a ready to use stored area.

There is a risk that the damage identified could cause the hoses to burst under pressure causing severe injury to operators and personnel within the immediate area.

The damage had compromised the integrity of the outer covering leaving the metal hose braiding exposed.

- All users and maintainers of the equipment must complete a full inspection of the hoses that are fitted to the Permaquip HSM70 Hydro Stressor for any burn or other visible damage to the hoses, as these are pressure hoses. Minor scuffs and abrasions are allowed however, if the examiner is unsure as to the integrity of the hose then it shall be quarantined, reported and inspected by a qualified fitter.
- Equipment identified as unserviceable must be labelled, quarantined and not be issued for use before such time as new parts are fitted. Equipment identified as serviceable can continue to be utilised.
- All faults should be reported to the equipment supplier so that repairs can be undertaken by a competent fitter.
