# Safety Advice

## Cembre LD-1PR rail drill bell housing failure

**Ref:** NRA 16/07

**Location:** Copley Hill Junction, Leeds

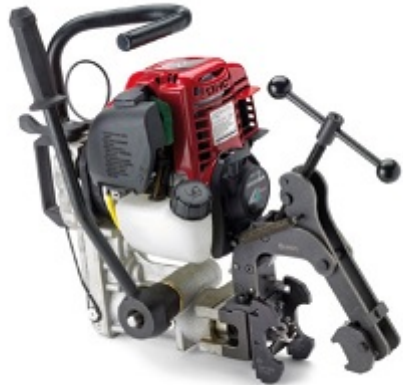
A Works Delivery signals team were using a Cembre LD-1PR rail drill to drill bonds at Copley Hill Junction Leeds. When undertaking drilling operations the bell housing of the drill failed and fell apart. No-one was injured on this occasion, though there is potential for a staff injury from any future failure.

A later inspection discovered an age-related crack had developed in the housing which had led to the failure. Excessive movement was also detected in the clutch bearing which may have added to the vibration which lead to the crack.

The unit is 14 years old and has been in full service for all of this time. The servicing of this unit is undertaken by Torrent.

- All users and maintainers of the equipment must complete a full maintenance visual inspection of the equipment with particular emphasis placed on the bell housing component and items which are over 10 years old. The date of manufacture is stamped on the data plate of the machine.

- All drills which show a date of 2006 (06) or older should be quarantined and inspected at the earliest opportunity by a plant servicing technician.
- Any items identified as suspect from the visual inspection must also be quarantined, reported and inspected by a plant servicing technician.

- Equipment identified as unserviceable must be labelled, quarantined and not be issued for use before such time as new parts are fitted or the equipment is replaced. Equipment identified as serviceable can continue to be utilised.

- All faults identified should be reported to the equipment supplier so that repairs can be undertaken by a competent fitter and to [Chris Hayden](#).
