Operational Restrictions on use of FSKII Circuit Breakers

Ref: NRA24-09

Date of issue: 30/09/2024

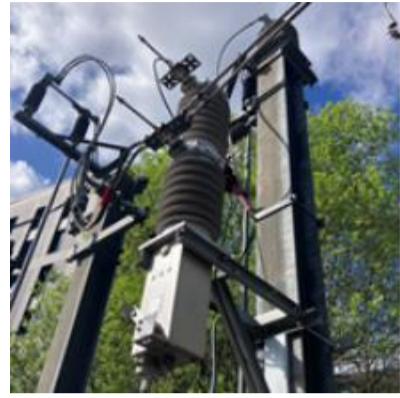
- During Test before Earth of an isolation between Finnieston and Rutherglen in Scotland, it became apparent that one of the electrical sections was still live.
- Subsequent investigations have found that a Circuit Breaker, which is an ABB supplied FSKII Circuit Breaker (top photo), had failed in the closed position.
- Whilst an investigation is undertaken, it is necessary to introduce restrictions on the use of ABB FSKII Circuit Breakers as detailed below.
- An update to this Safety Advice will be provided when more information is available.

Where an ABB FSKII Circuit Breaker is being used to effect an Emergency Switch-Off, a second open point shall be created in series with the FSKII breaker before confirming that the ESO has been taken.

Where available, the second open point should be a motorised air-break disconnecter (e.g. Busbar disconnecter), but otherwise may be the TNO/DNO Circuit Breaker, Feeder circuit breaker, bus coupler, set of track feed circuit breakers or overhead line switches and may be another FSKII circuit breaker.

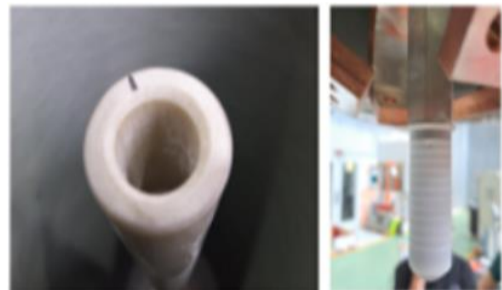
- The insulating part of the operating rod (left photo) had become detached from the metal drive rod (right photo).
- A failure of the operating rod in this manner leaves the Circuit Breaker's vacuum bottle sprung closed.
- Whilst this is the first time ABB have seen a failure of this nature and the FSKII is a widely used circuit breaker, further investigations are urgently underway to understand the extent of devices which may be affected by this defect.

Where practicable, the same principle of creating a second open point should be applied to overhead line isolations.

Where such facilities are not practicable to use, then secondary indications (where available) may be used to confirm that the associated circuit breaker has correctly opened (e.g. through a low volts alarm). The ECO should draft and use a switching schedule to identify the actions being taken to disconnect the equipment and validate the associated secondary indications.
