Safety Bulletin

Serious leg injury whilst lifting precast units

Ref: NRB 16/15

Location: Maerdy Bridge near Newport, Wales

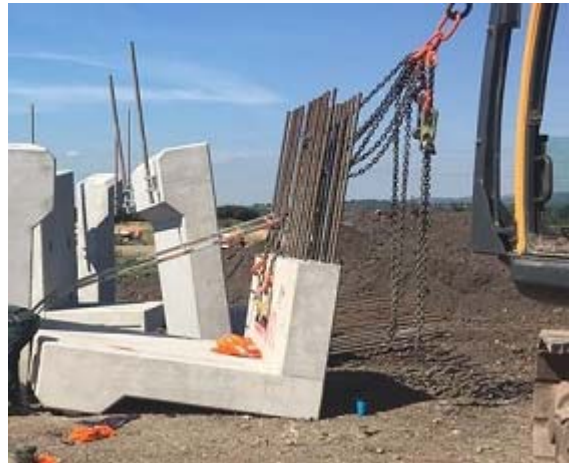
On the morning of Monday 15 August, a slinger/signaller was working with a 48 tonne excavator to relocate L-shaped precast bridge parapet sections in a compound at Maerdy Bridge near Newport, Wales

As the slinger/signaller stood on a ladder and removed the upper lifting chains from a unit it toppled toward him.

He escaped by climbing over the falling unit but his right leg was struck above the ankle causing multiple fractures.

- What information should be provided by the designers regarding the handling, lifting and storage of precast components especially where the centre of gravity is not obvious?
- What planning is required to handle such units including preparing the ground and lifting plans?
- What other controls e.g. ballasting or propping could be employed to prevent movement?
- What communication and briefing is required prior to handling large components?
