# Safety Bulletin

## Collision and derailment in a worksite

**Ref:** NRB 16/03

**Location:** Ivybridge, Devon

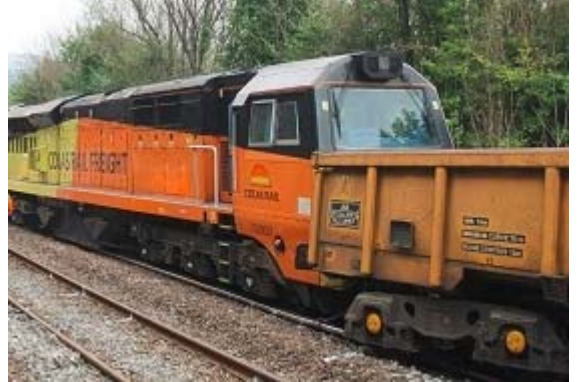
A collision and derailment occurred in a worksite at Ivybridge (MLN1 Down Main at 235m 11c) on 27 February 2016. A loaded engineering train of 1119 tonnes gross weight collided with a rake of stationary, loaded Falcon wagons. The worksite was for a planned track relay.

At 07:40 the driver of the engineering train was given permission from the Engineering Supervisor (ES) to enter the worksite. A few minutes later, after travelling three quarters of a mile down a falling gradient, the train collided with the back of the eight stationary Falcon wagons.

Initial evidence indicates the locomotive had reached 35mph but managed to brake to 13mph at the point of collision. All wheels of the locomotive were derailed, as well as two other wagons.

- What communications should take place between the ES (worksite) or PICOP (possession) and the driver of any train, On Track Machine or Road Rail Vehicle?
- At what speed can rail movements safely be made within a worksite or within a possession?
- Is the meaning of proceeding at caution understood?
- How is that speed controlled?
- How are communications for all rail movements monitored and managed in a possession and worksite?
- What can impact the effectiveness and understanding of communications during work such as this?
- What can you do to help prevent a recurrence of this type of accident?
