## Robel Battery Powered Tamper Incident

Ref: NRB22-08

Date of issue: 23/08/2022

Location: Eastleigh Depot, Wessex, Southern region

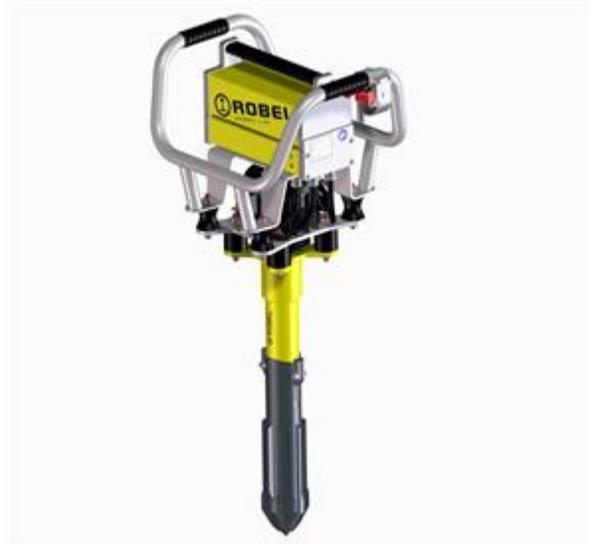
The Eastleigh P-way team arrived at the stores on the 31/07/2022 at 23:54 to collect tools and equipment for their planned works. A Robel Lithium-Ion battery was removed from the charger and placed on a Robel 62.20 vertical tamper. The test button was pushed, and a loud bang and a puff of smoke was emitted from the Robel vertical tamper unit. This was reported to Control and the section manager.

The section manager instructed the team to place the equipment in quarantine. The following morning at 09:25 hrs the section manager and supervisor went to the stores to investigate further. During the initial investigation the battery was unclipped from the vertical tamper and placed on the floor to inspect further. After approximately 2 minutes they heard a hissing noise coming from the battery, followed by smoke, which began filling the stores. The stores were evacuated, and the fire brigade were called, who extinguished the fire with no other damage.

This incident is currently under investigation by the manufacturer and Network Rail Technical Authority Plant Team have notified the Regions that a suspension of the use of these assets is to be instigated until the results of this investigation are completed and the assets are confirmed as 'safe to use'.
