## Combined Pollution Events Learning

<b>Project Name:</b>	Several
<b>Project Number:</b>	Several
<b>Locations:</b>	Warden Bridge, Wamphray, Lamington, Forteviot
<b>Date and time of event:</b>	Throughout 2016 to 2019
<b>Date of issue:</b>	June 2020
<b>Contact:</b>	Capital Delivery, Scotland
<b>Ref:</b>	Learning from Events Week

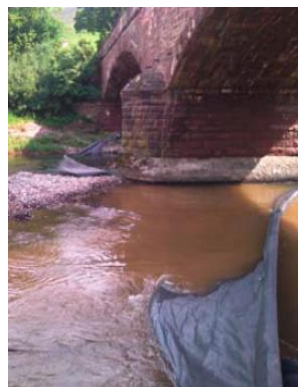
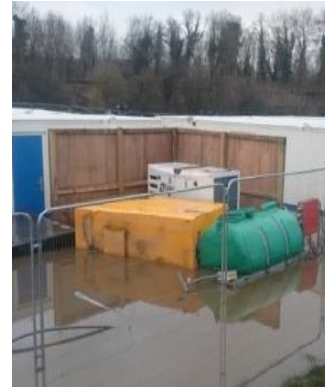
During CP5 there were several events, where water bodies were impacted by project works, which caused silt pollution, bank erosion, harm to a nature reserve that resulted in warning letters from the regulators.

Water courses also impacted project works, due to flooding, which resulted in a fuel spill of more than 400L at one site & other sites being stood down as those had underslung scaffolds damaged or temporary defences were over topped as a result, which caused environmental and safety risks.

What are the appropriate permit and licence conditions and control measures needed to monitor site status, including consents constraints or self-reporting schedules and plan “when to stop” works due to pollution?

Assess foreseeable risk of flooding.

Do not rely solely on historical data that indicates a low frequency of flooding. Consider the increasing frequency in extreme climate events and then assess and plan accordingly.
