Shared Learning

The Thameslink Programme

Issue Number: TLP089

Title: Work in Live LV Switch Room

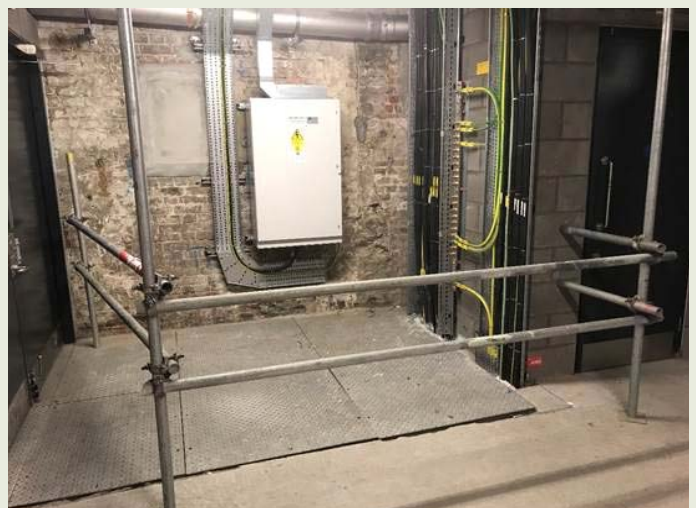
Photo of Event :

There are controls in place to make sure works are authorised and that access is allowed via an access permit system. This system was followed, however additional work (scaffolding handrail) was required to be carried out and was not authorised by the permit. Metallic equipment which was being used is not permitted whilst the equipment in the plant room is live. There was therefore a risk to the team and to the operations of the station.

Scaffold handrail erected in the LV room.

- The WPP was reviewed and TBS was revised.
- Requirement of protection for services when floor plates are lifted in LV rooms.
- All personnel were briefed on the requirements to access LV / HV switch rooms.
- Reinforcement of the permit process communicated at the Just & Fair Culture interview with the project personnel involved.
- The Engineer was rebriefed on the Point of Work Risk Assessment (PoWRA) process and has undertaken refresher training on risk analysis and risk perception.
- Audit to be carried out to assess the effectiveness of the electronic permitting system.
