No: IGS 222

## Infrastructure Group Safety Bulletin

# OHL Snagging risk when using Unimog RRV Mobile Elevating Work Platform (MEWP)

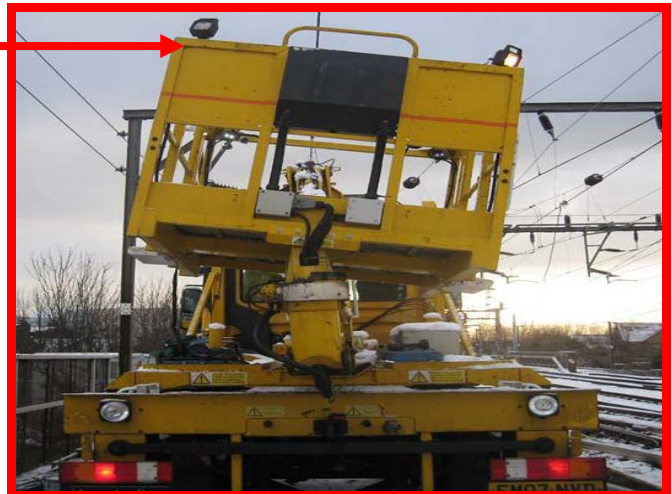
**Background:** An incident occurred on the 7/01/10 during remedial de-wirement works at Hackney Downs. A MEWP basket handrail became snagged on a splicing rig; the vehicle was being moved a short distance along the track when it came into contact with the rig. This 'snagging' put a heavy sideways loading on the basket, this resulted in the failure of the basket load cell which is designed primarily for heavy vertical loading. The work was stopped and the arm lowered into the parked position to enable the two members of staff to climb out safely.

OLE Rig snagged here  
when basket was rotated  
90°

**Note:** The MEWP basket safety bolts functioned correctly and retained the basket on the support arm, although no injuries occurred during this incident, it is subject of a Local Investigation.

**Operators, Machine and Crane Controllers** working with elevated MEWPS must, before all movements, assess the situation and take appropriate action to avoid moving the basket or the vehicle if there is any risk of striking or coming into contact with any part of the infrastructure. (For example, before moving off the Operator should ensure that the splicing rig is tied up.)
