No: IGS 244

## Infrastructure Group Safety Bulletin

### Action to be taken in the event of loss of ballast support on bridges

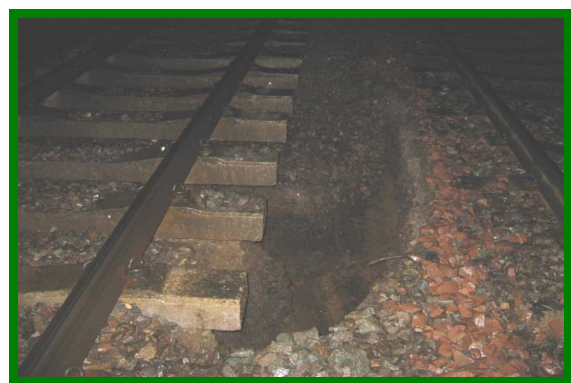
Initially reported as a rough ride, the fault was discovered to be a significant hole in the structure and a serious loss of ballast to the up line.

Figure 1: Hole in Ballast

**Where there is a loss of track support over a bridge such that the line is thought unsafe for the passage of trains, staff are reminded:**

- The adjacent tracks must also be blocked until the on-call NR Route Structures Engineer agrees it is safe for the passage of trains to be resumed.
- This agreement will follow the examination of the structure by a competent bridge examiner or Network Rail Structures Engineer.
- Where the bridge carries four or more tracks; the on call Route Structures Engineer may advise by phone, the lines other than those directly affected, that can remain open to traffic.

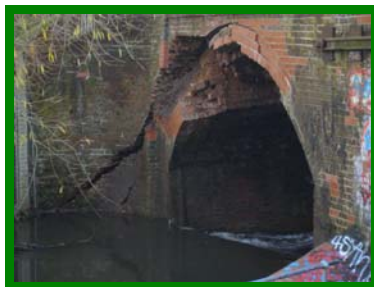
Last year a river scour incident occurred, causing the partial collapse of a bridge structure.

Figure 2: Damage to structure

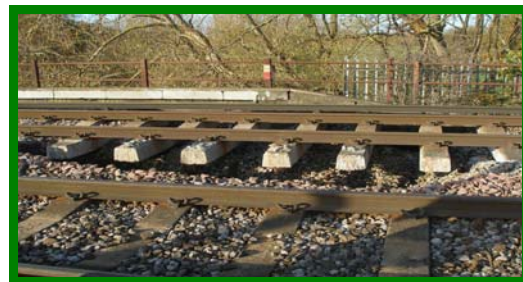
Figure 3: Visible damage under track
