No: IGS 247

Infrastructure Group Safety Bulletin

Injury During Lifting Operation

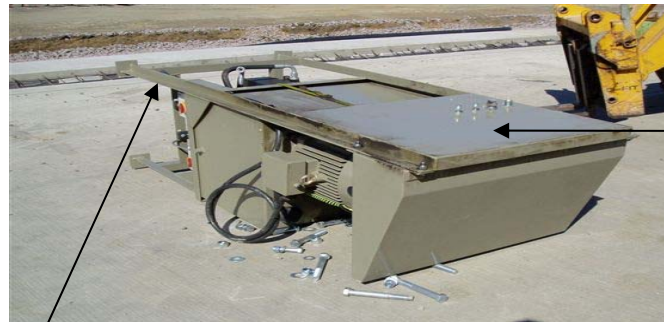
A member of staff recently sustained injuries while assisting with the movement of equipment on site using a telehandler. The accident occurred when the load became unstable and subsequently came into contact with the individual. An investigation into this accident has commenced.

The majority of the load weight is positioned at the top of the equipment

Telehandler Forks used under legs to lift equipment

Whilst the cause of this event is not fully known, all employees engaged in either planning or lifting/loading activities are reminded that safe lifting requires the following:

- **All lifting operations must be planned by a competent person and a lifting plan produced and adhered to.**
- **All loads must be adequately secured to prevent any unplanned movement or collapse either in transit or storage, this is regardless of the distance the load has to be moved**
- **Any person acting as Banksman must be in a safe position whilst carrying out such duties and the telehandler driver must stop the vehicle immediately if the banksman disappears from view**
