No: IGS 203

## Infrastructure Group Safety Bulletin

### Graffiti using Hydrofluoric Acid

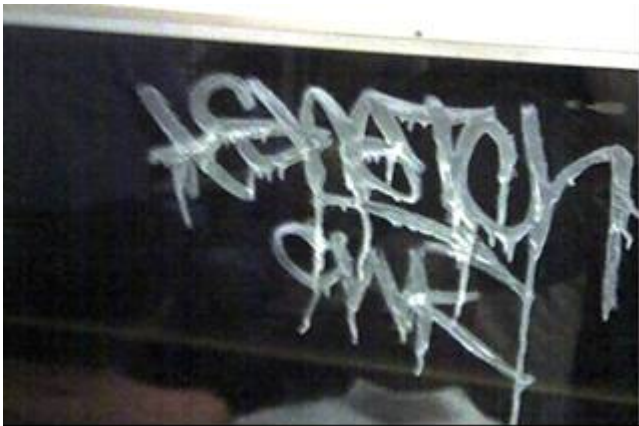
Graffiti vandals have been using Hydrofluoric Acid (HF) to burn their "tags" (names) into glass surfaces.

If staff feel suspicious of any container, bingo marker or similar, or if they identify an area of "tagging" or "etching" on glass similar to the first picture, above, then they MUST REPORT this to their Line Manager and request support in dealing with the issue. Under no circumstances should staff attempt to clear up the receptacles.

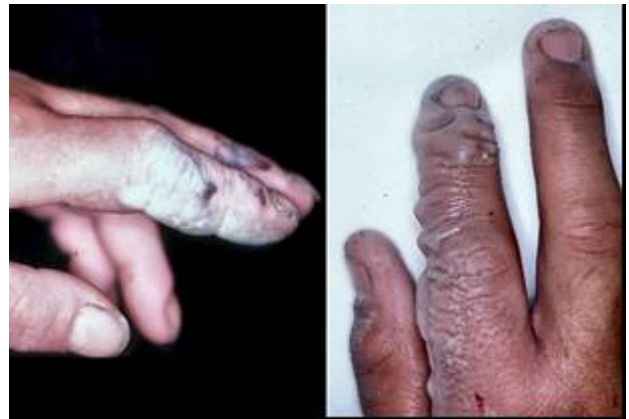
Bingo Dabber

Acid etching is a form of graffiti that has started to show up in the UK. This brief is intended to inform staff of potential issues surrounding the use of substances to acid etch glass. In many cases, the etching acid (containing the hydrofluoric acid and other harmful substances) is transferred into empty bingo dabbers or large markers wrapped in masking tape. It is extremely corrosive and serious injuries may occur if it comes into contact with your skin. HF will continue to burn into your skin, even if you think you have washed it off.
