No: IGS 213

Infrastructure Group Safety Bulletin

Volvo Compact Excavator Dipper Arm Failure

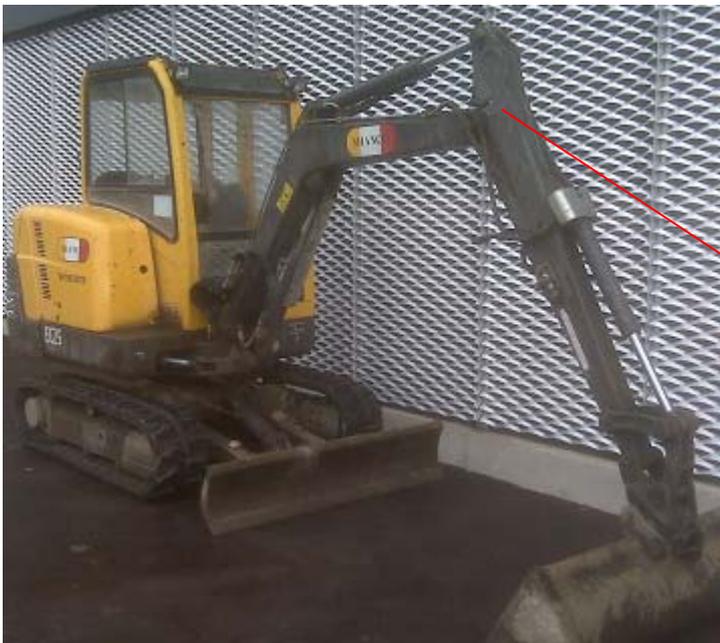
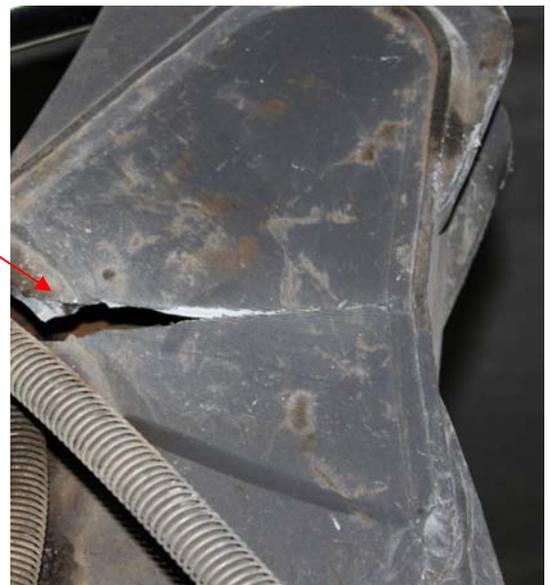
On the 5th October 2009 a Volvo EC25 compact excavator suffered a dipper arm failure whilst in operation on a worksite loading dumpers with spoil.

The pictures above show the failed dipper arm. The failure has been identified as a manufacturing fault with the dipper arm welding.

Confirmation from the machine supplier that the machine has been checked as per the Volvo Service Bulletin No 42K version 1 (attached) prior to use.
