No: NRS 337

Network Rail Safety Bulletin

Axle Lock Check Valves on Colmar RRVs

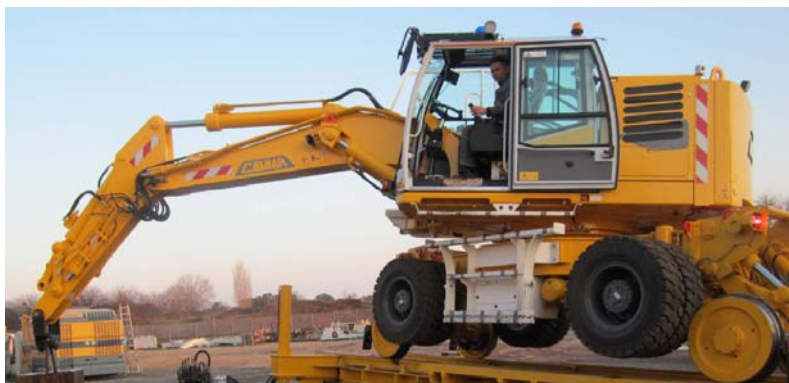
Example of affected Colmar RRV

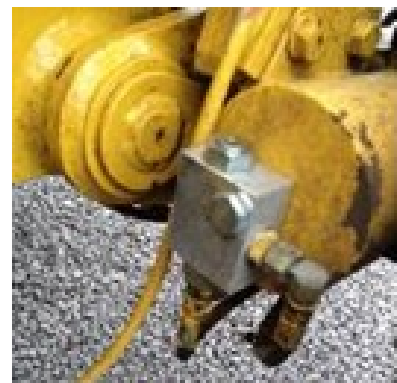
Following a recent low speed derailment of a Colmar T4300 RRV, a number of faults have been found in the axle lock check valves located on top of each hydraulic ram on the floating axle. These have included broken springs and build-up of contaminants in the hydraulic oil.

The contaminants in the oil have a direct effect on the correct operation of the axle lock check valves, reducing their effectiveness to operate as designed and lock/unlock the floating axle. Additional checks on the axle lock check valves and amendments to maintenance plans have previously been recommended to mitigate the risk of this fault following NIR 2321 in 2007.

Axle Lock Check Valve

All Colmar RRVs must be inspected with immediate effect and the following action taken:

- Thorough and detailed inspection of the affected axle lock check valves components.
- Based on the outcome of the detailed inspection, repairs to be carried out in line with instructions previously issued in NIR 2321.
- Review maintenance plans for all Colmar RRVs to ensure that removal, cleaning and checking of the axle lock valve blocks are included every 250 hours or 2 months for the first year. If no issues are raised within the year then the frequency can be reduced to annual.
- Amend maintenance plans if necessary.
- POS Representatives to verify that inspection has taken place before deploying the vehicle on the operational infrastructure.
