# Safety Bulletin

## Train strikes 'gantry rail' placed in cess

**Ref:** NRB 15/09

**Location:** Derby Road, Felixstowe

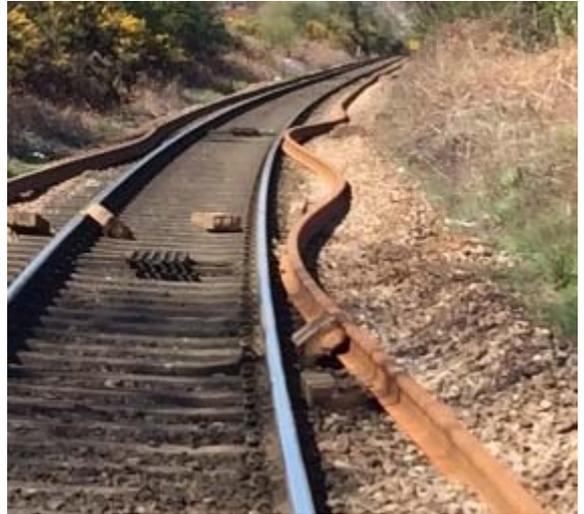
On 20 April 2015 a gantry rail which had been positioned for the plain line renewals works at Derby Road moved due to expansion.

The gantry rails are used as part of the renewals temporary works and had been joined on site into 709 foot lengths two weeks prior to the main works.

Due to heat expansion the rail came into close proximity of the adjacent running rail and was struck by a passing train.

Whilst this did not cause significant damage to the infrastructure or the train, the potential for damage was high.

- How do you know that you have effective risk assessments for all your temporary works?
- How do you consider both actual and potential site and environmental conditions such as hot weather in early spring?
- How is risk considered when determining the split between main and preparatory works? Would your current arrangements help prevent a similar incident to this?
- How and when would consideration be given to measures such as a supplementary inspection regime and watchmen for sites identified as high risk?
- As a precautionary measure IP-Track will require that DPE approval is obtained from for any sites where rail lengths greater than 709' are proposed prior to core works (welded or plated), this is a temporary measure until the findings of the investigation are delivered.
