No: NRS 340

Network Rail Safety Bulletin

Deployment of Lookout Operated Warning Systems (LOWS)

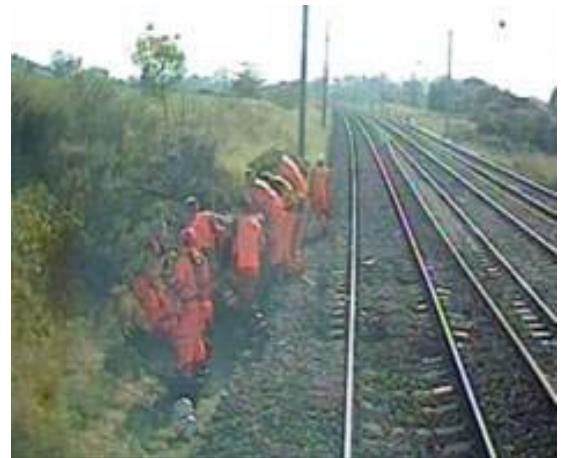
There have been recent incidents at Market Harborough, Hest Bank and Thatcham where Network Rail staff and contractors have not been adequately protected by the safe system of work involving Lookout Operated Warning System (LOWS). No one has been injured in any of the reported incidents, but workers had to move out of the path of trains with insufficient warning time. In each case, subsequent analysis of the LOWS data-logger has confirmed the equipment to be operating as designed.

Forward-facing image still from the recent near miss at Hest Bank, LNW

- Is every effort made during **planning** to undertake work in available possessions, line blockages, behind fences / barriers or separated by distance?
- How can you be certain there is **no train** between the lookout and worksite when work (re)starts?
- Have you encountered **potential distractions** when on site from the environment such as from members of the public, station operations or a noisy environment such as a level crossing? What would you do to make the arrangements safe in these circumstances?
- Are LOWS lookout duties planned to facilitate breaks at least every **two hours** as recommended in the [lookout e-learning](#)?
- When acting as lookout, if you feel your **concentration** has reduced do you send a "train on" warning and agree a suitable break with the LOWS Controller?
