No: NRS 344

Network Rail Safety Bulletin

Failed Lifting Equipment – Sumner Roust-A-Bout R-250

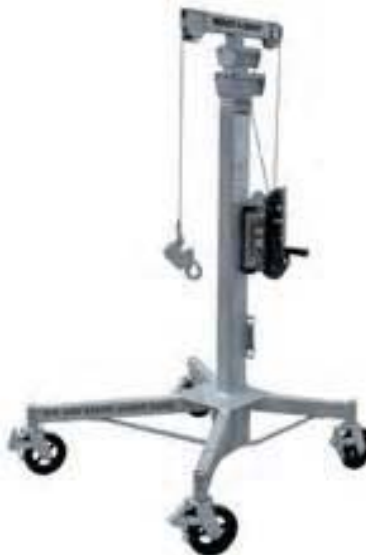
During a recent lifting operation involving the use of a Sumner Roust-A-Bout R-250 lifting hoist, a cable failed without warning which caused a section of steelwork to fall within a designated site area. The initial cause is not known. As part of the investigation into how the failure occurred, it was discovered that internal elements of the lift were not accessible for routine inspection.

Sumner Roust-A-Bout R-250 lifting hoist

Until we are certain that this cannot happen again, the **Sumner Roust-A-Bout R-250 lifting hoist** is to be taken out of service with immediate effect and alternative means of lifting to be used.
