Safety Advice

Noxious fumes from Ford staff messing vehicle

Issued to: Network Rail line managers
Ref: NRA 15/04
Date of issue: 22/05/2015
Location: Stevenage
Contact: [Julia Territt](#), Business Manager (Road & OTP), National Supply Chain

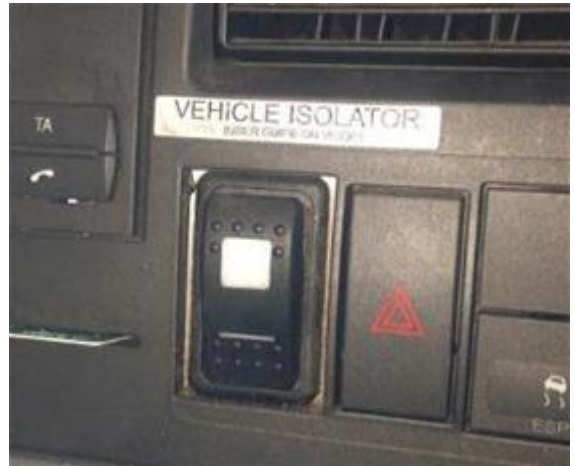
- Auxiliary leisure batteries should be isolated when not in use.
- If you identify a smell whilst driving, pull over in a safe, legal place and turn off the ignition (do not re-start the engine or turn on the ignition).
- Use the dash mounted 'vehicle isolator' switch (as pictured above) to isolate the welfare facility power.
- DO NOT re-set the switch again to restore power to the welfare facilities.
- Ventilate the area fully, opening windows and doors safely, and do not re-enter the vehicle.
- Contact the breakdown recovery service on 0845 600 6767, option 2, and arrange recovery to a safe location. At the same time arrangements will be made to book the vehicle into a garage for the battery to be replaced.

NSC's Road Fleet department has commenced a programme of booking in over 2000 vehicles in order to have the auxiliary leisure battery replaced.
