The Thameslink Programme

Issue Number: TLP044 Title: Access Permanently Closed Putting Staff at Risk

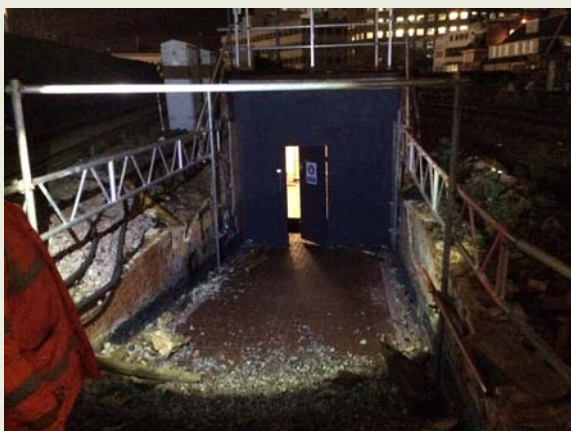
Photo of Event :

Immediate - Doors that have direct access to the track off platform 5 were screwed closed from inside.

Access door that was secured closed.

- Locks on the door were changed to an abloy lock and access arrangements including securing the door were reached between the organisations.
- A review meeting has been held to review the CDM co-ordination arrangements at London Bridge.
- Planning meetings are being reviewed to include interfaces and requirements.
- The PICOP packs which detail access details are to be shared with Principal Contractors.
- All organisations involved are reviewing the communication arrangements between key roles during nightshift.
