Lessons Learnt from a Formal Investigation

Document ref: NRRP 11

Title: A close call involving a track patrolling team working Red Zone with a Lookout Operated Warning System (LOWS)

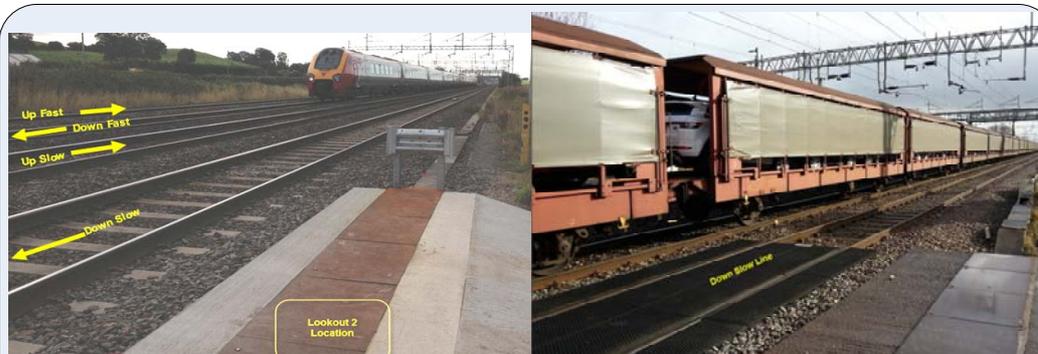
Example photo of the location of the Lookout.

Example photo of the type of train obscuring the Lookouts view

Line Managers should thoroughly examine the effectiveness of any safe system of work that they approve which has been planned or amended at short notice
