EVENT LEARNING

014

Location: *Rutherglen & Coatbridge Electrification Project*

Works Taking Place / Incident Type: *Piling Operations*

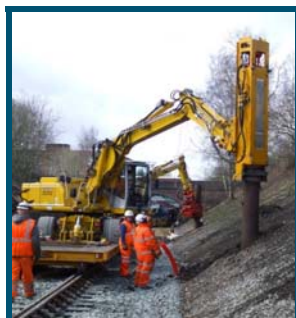
In the first instance the culvert was situated over 8 metres below rail level, it was not visible at track level and the piling team was unaware of its presence.

Culvert 1: The culvert had not been identified prior to the work commencing. Consequently, the culvert was not visible and there were no identification markers at track level.

- On future projects, ensure that all underground structures (UTX, culverts and under bridges) are identified at track level by the provision of ID markers.
- Where teams are tasked to carry out trial holes, the team should note and be responsive to any surrounding environment which may affect the installation of infrastructure.
- Future topographical surveys should be thorough and investigate all surrounding environment, especially in areas where ground breaking is to take place. Any evidence of 'hidden' infrastructure should be fully investigated and all findings noted.
