EVENT LEARNING

023

Incident Date / time: October 22nd 2015 / 13.20hrs
Location: Auldgirth, Dumfries and Galloway
Works Taking Place / Incident Type: Remedial work to site / Machinery / equipment use
Issued By: Safety & Sustainable Development Team
Project Name / Number: Renewals Collaborative Delivery Programme / 143680
For the attention of: All Scotland and North East

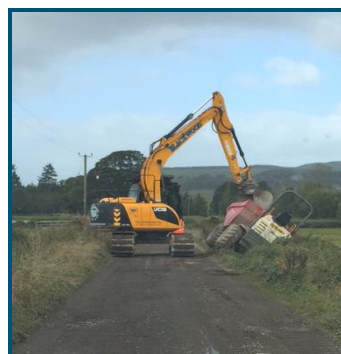
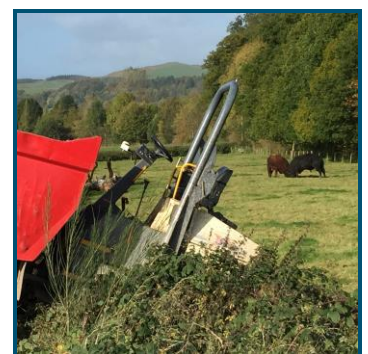
A 9 tonne dumper, with a skip two thirds full with damp spoil, tipped over at the side of an access road. The driver lost control after encountering some potholes and veered onto the soft verge before tipping down a small embankment at the edge of a field. There was minor damage to the landowner's fence and a small oil spill from the dumper. The operative escaped unharmed however there was potential for serious injury.

- Dumper fitted with a roll bar
- Operative wearing a seatbelt
- Safety conversations : operative previously engaged with construction manager around use of seatbelts on **all** types of plant
- Good working relationship and contact arrangements with the landowner enabled:
 - livestock to be moved promptly
 - rapid response for spill containment and removal of contaminated soil
 - fence line reinstatement

- Lack of speed signage and monitoring on access road
- Risks for damage or injury involving livestock or other users of access road not assessed
