Shared Learning

The Thameslink Programme

Issue Number: TLP032 **Title:** London Bridge Failure of Lifting Sling (16th April 2015)

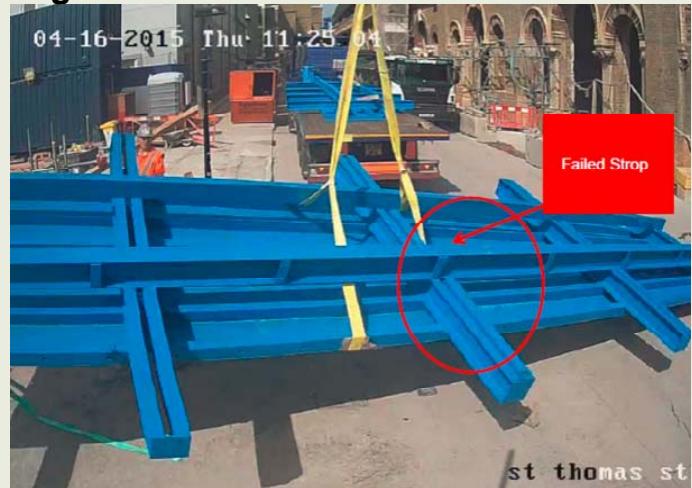
Diagram/ Photo of event:

A lifting sling failed whilst a bespoke shutter was being transported to a storage area immediately after it had been lifted off a delivery lorry. The load was approximately 3 feet off the ground.

- **Procedure:** The Crane Supervisor (CS) and Slinger did not use an approved method of packing between the webbing slings (straps) and the edges of the shutter. A cardboard material was used instead of a 'sling protector', which was not available at the lift location and would introduce a time burden.

- **Procedure:** A Point of Work Risk Assessment was not carried out which would have assessed the specifics of the lifting operation prior to slinging and would have identified the 'sharp' shutter edges

- The requirement to include the transportation, loading and lifting will be addressed with the manufacturer/supplier
- A WPP will be produced which will include a requirement for the Crane Supervisor to carry out a Point of Work Risk Assessment to assess the risks associated to each lifting operation
- The Task Brief was revised and will now include instruction on inspecting all accessory facing edges prior to test lifting
- Specific shutter lift plans will be introduced for each type of shutter
- Briefs were given to all lifting personnel on webbing slings and types of sling protectors that are available on site
- Minutes will be produced from all risk reviews meetings. A section on logistics which will include transportation and lifting operations will be included in the meeting as well as a site visit for all attendees where the Risk Review Rating is Medium or High.

- Any materials or equipment that requires to be offloaded or handled using mechanical lifting methods e.g. forklift, crane, Hiab etc should either have designed lifting points or there should be defined methods for lifting them e.g. slinging points, prescribed lifting tackle etc
- A safe method of work, including a lifting plan should be in place
- Any plant being used to lift materials should be adequate for undertaking the lift
- Any lifting accessories being used should be adequate to undertake the lift
