Shared Learning

The Thameslink Programme

Issue Number: TLP 047 Title: Earthing on Viaduct Structures

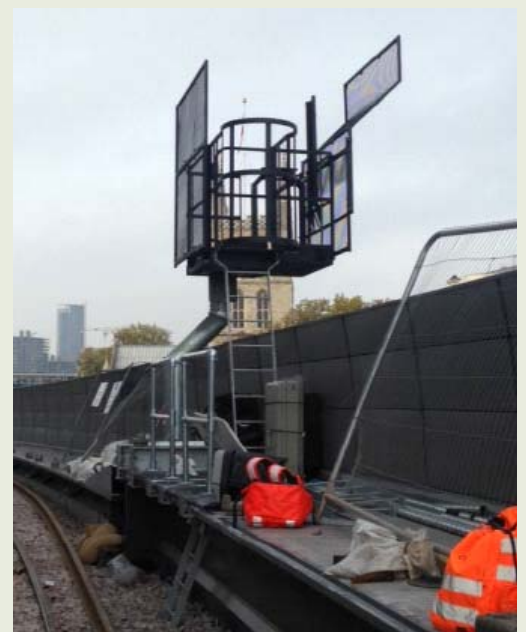
On the 25th October 2015, as part of Signalling & Track installation work, there was a requirement to fix mesh panels to the sides of a signal structure on the new Western Approach Viaduct. To gain access to one side of the signal the easiest method was to approach the task from the existing viaduct using an Road Rail Vehicle to lift the panel into position before fixing.

During the lift, the mesh panel came in contact with both the signal structure and the arm of the machine, this resulted in arcing between the two pieces of metal and part of the mesh panel caught fire for a few seconds.

Signal structure on Western Approach where mesh panels were fitted

The investigation has identified that the Western Approach Viaduct system has been fitted with lightning protection and the Borough Market Viaduct (BMV) and Borough High Street Bridge have a class 1 architectural and functional street lighting. These provide a good earth path for the complete viaduct system incorporating:

Convention for the South East has been to leave metallic bridge structures floating and not to provide any direct earth connections. This arrangement has associated hazards which are accepted as inherent in a DC electrified railway and does not guarantee that the structure is not earthed.

Recent data indicates that rail to earth voltages in the region vary between -10 and +40V. A recent measurement of the Up Charring Cross running rail to BMV potential was found to be in the range of 8 to 12V. These are not potentials that are hazardous to human health and are below the prescribed limits. However, coupled with an extra low resistance through earth could lead to currents that could damage infrastructure and cause other secondary hazards

- Once the traction system is commissioned through the new viaduct system as part of stage HL07, concluding on the 4th January 2016, this hazard will be present. This is regardless of whether the traction supply is isolated, as a voltage potential remains in the running rails at the levels quoted above.
- The planning of works within the vicinity of the structures needs to account for the potential for this to occur if a conductive path is created between the running rails and the metallic parts of the structures or other metallic elements connected to the structures (e.g. signals, acoustic barrier).

- The risks associated with retaining the earthed arrangement and with removing the earth have been assessed and concluded that both arrangements are tolerable. However, the earthing should be removed to make the hazards associated with these structures comparable to other metallic bridge structures across the DC electrified network.
- Plans are being developed to remove the earth connections but until this has been verified and communicated as complete, it is important that staff undertaking the planning and implementation of works on the viaduct structures are aware of the difference in the risks.
