### **Kubota placed on line open to traffic**

**Ref:** NRL 17/04

**Date of issue:** 03/11/2017

**Location:** Rookery Bridge, Crewe

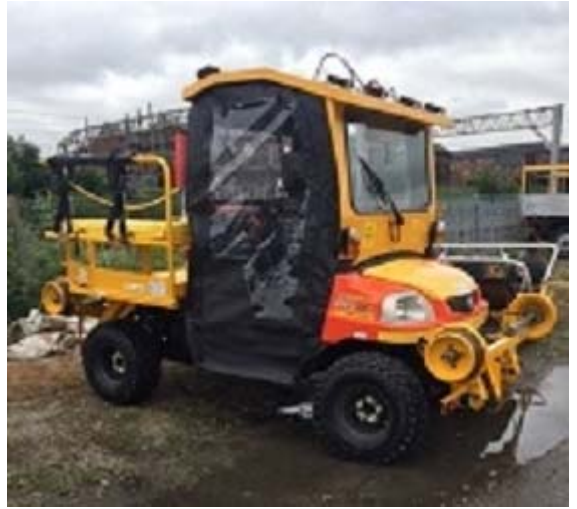
At 00:02 on 3 January 2017 a Kubota road rail vehicle was placed on an open goods line during a T3 possession of the adjacent main lines at Rookery Bridge between Crewe and Sandbach.
