Safety Bulletin

Person struck by falling over head wire

Ref: NRB19-03

Location: Dollymans Bridge at S30/19 on the Up Southend

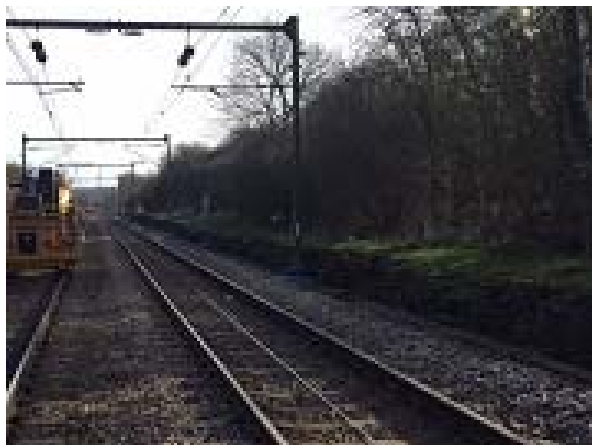
As the work progressed, some of the supporting temporary materials failed which resulted in the contact wire dropping to the ground uncontrollably, striking the injured person on the head and shoulders.

- What assurances do you have when making late changes to planned tasks that all risks have been assessed and controls are implemented, briefed and understood as required?
- Are the "Take 5" principles applied before, during and after your work?

- Are the methodologies and processes checked to ensure they are still applicable as the work progresses?
- Who can authorise late changes to a safe system of work / SWP?
