Safety Bulletin

Tampering of Automatic Fire Detection System

Ref: NRB23-08

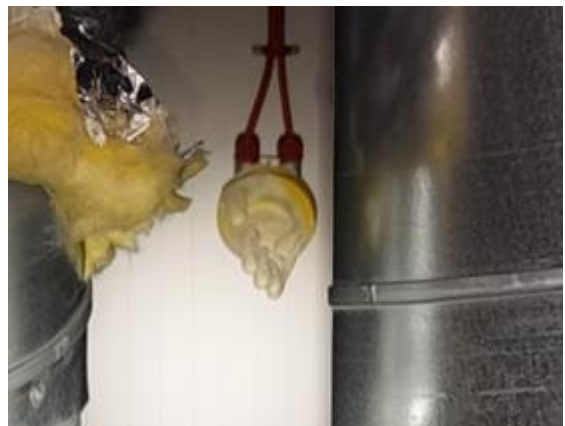
The fire detector was located in the ceiling space of the male toilets between two sets of ducting.

A rubber glove was placed over the smoke detector, preventing potential smoke in the event of a fire from activating the audible fire alarm. The incident was reported to senior management with a Close Call being raised. The glove was then removed, when safe to do so, to retain the full working order of the fire system and safety of the occupants.

- Ensure all automatic fire detectors are checked and inspected on a six monthly basis by the PRFS and record findings in the Fire Safety Log Book - [NR/L3/FIR/109/F008](#)
- Any works completed which could affect an automatic fire detection system should have an approved method statement in agreement with the appropriate asset engineer. On completion of works, all contractors must verify and assure all systems are restored to their original status.
